U. S. CHEMICAL SAFETY AND HAZARD INVESTIGATION BOARD

INVESTIGATION REPORT

PROPANE TANK EXPLOSION (2 DEATHS, 7 INJURIES)

Herrig Brothers Feather Creek Farm
Albert City, Iowa
APRIL 9, 1998

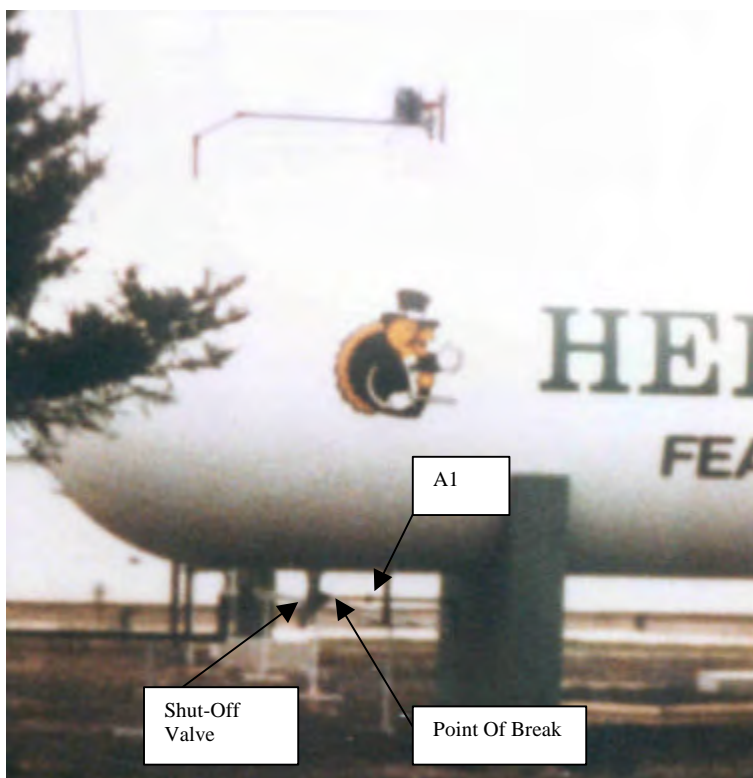
Figure 4. Liquid Line Shut-Off Valve and Point of Break

The first component in the liquid line leading to the vaporizer was a 3-inch excess flow valve. This metal valve was threaded into a 3-inch pipe coupling that was welded to the bottom shell of the tank. This excess flow valve was connected to a manual shut-off valve by a 2-inch diameter pipe (nipple) that was 2 inches in length. This metal 90°-angle valve changed the orientation of the liquid line from a downward direction to a horizontal and eastward direction. Two bushings (adapters designed to permit the joining of pipes with different diameters) connected the shut-off valve to a ¾-inch schedule 80 carbon steel pipe (outlet pipe). This outlet pipe ran to the east for approximately 30 inches toward the concrete saddle supporting the tank, and then turned downward for approximately 7 inches. This segment of pipe was subsequently labeled “A1” for evidentiary purposes (See Figure 4 below and Figure 29 in Appendix B). The outlet pipe then turned again to the north and ran to the vaporizers on a series of steel supports spaced at regular intervals. These supports placed the outlet pipe approximately 3 feet above the ground for its entire 37-foot course from the tank to the vaporizers. The arrows in Figure 4 point to liquid line components and to the approximate location of the break that occurred under the tank.

The liquid line (which measured approximately $\frac{3}{4}$ -inch inside diameter) was completely severed from the tank at the location where it was connected to a manual shut-off valve directly beneath the tank (see Figure 6, item A20). An excess flow valve protecting the liquid line (see Figure 6, item FV3) failed to function, and propane leaked out of the tank at the point of the break. As the liquid propane sprayed out of the tank, it rapidly changed to vapor. Propane vapor may have also leaked from the damaged vapor line.⁸ Propane from the damaged pipes formed a cloud, and within a few minutes this propane vapor ignited. Although the source of ignition was not conclusively established, the likely source was the direct-fired vaporizers.⁹ A fire, fed by the broken liquid line, began burning vigorously under the tank.

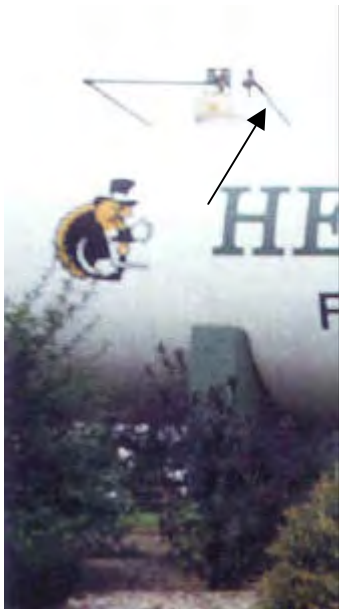
Figure 5a. Southern Exposure

The vapor line involved in this incident exited the tank vertically from a 2-inch excess flow valve screwed into the manway⁷ on top of the tank. A small segment of pipe connected this excess flow valve to a shut-off valve. This 90°-angle valve changed the course of the vapor line to a horizontal direction. The vapor line then ran northward until it extended beyond the side of the tank and then ran downward to the same elevation as the liquid line. From this point, the vapor line ran parallel to the liquid line on the same series of steel supports until both lines reached the vaporizers. Figures 5a and 5b are photographs of the west end of the tank that illustrate the vapor lines exiting the manway. The arrows point to the vapor line that ran to the vaporizers.

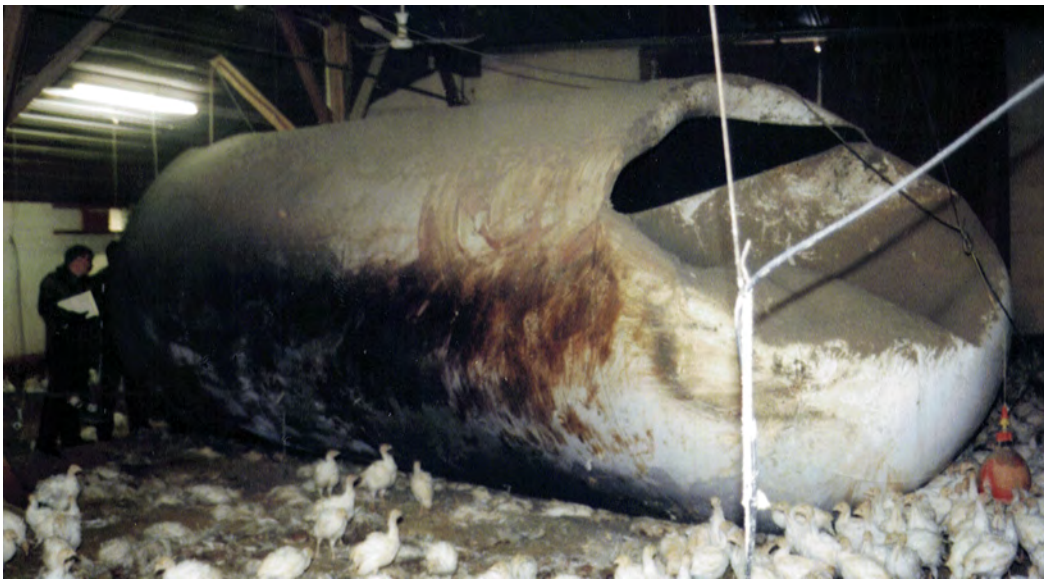
Figure 10. Piece of 18,000-gallon Tank Inside Turkey Barn (1f)

diameter) was propelled to the east, through the end of a turkey barn wall (see Figure 2, item 1f) and came to rest inside the barn (see Figure 10). This piece, which represented about one-half of the tank, caused the damage to the west end of turkey barn 1f, shown in Figure 11. A second large fragment traveled north, causing the damage to another turkey barn shown in Figure 12. (See also Figure 2, item 1g for location of the barn). Two other large pieces traveled in a northwesterly direction and landed between a workshop and a feed storage bin. One of these pieces likely caused the damage to the two-story workshop shown in Figure 13. Smaller tank pieces traveled in various directions. Some of these pieces were discovered in the grain fields that surround the property. A map that depicts the location of tank debris following the explosion is provided in Appendix C.

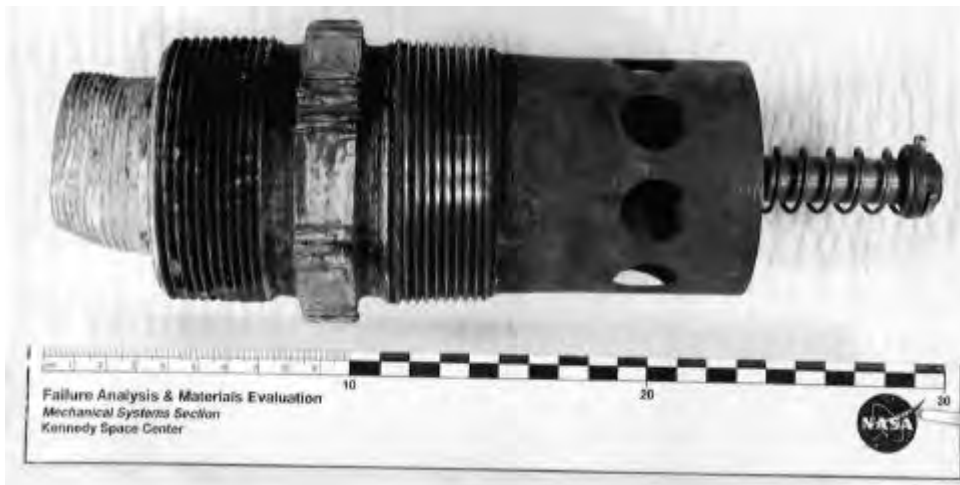
FIGURE 5

The liquid line that ran from the tank to the vaporizers was equipped with an excess flow valve, which was designed to automatically close when the flow through the valve exceeded a predetermined rate -- the closing rating. This particular valve had a closing rating of approximately 200 gallons per minute. In the event of a complete break in the outlet pipe downstream from the excess flow valve, the valve should have closed and greatly reduced²⁴ the flow of propane from the broken pipe. When the ATV severed the liquid line, however, the excess flow valve failed to close because the flow capacity of the outlet piping system was less than the closing rating of the excess flow valve.

Liquid flow control valve FV3 as-received in the laboratory.

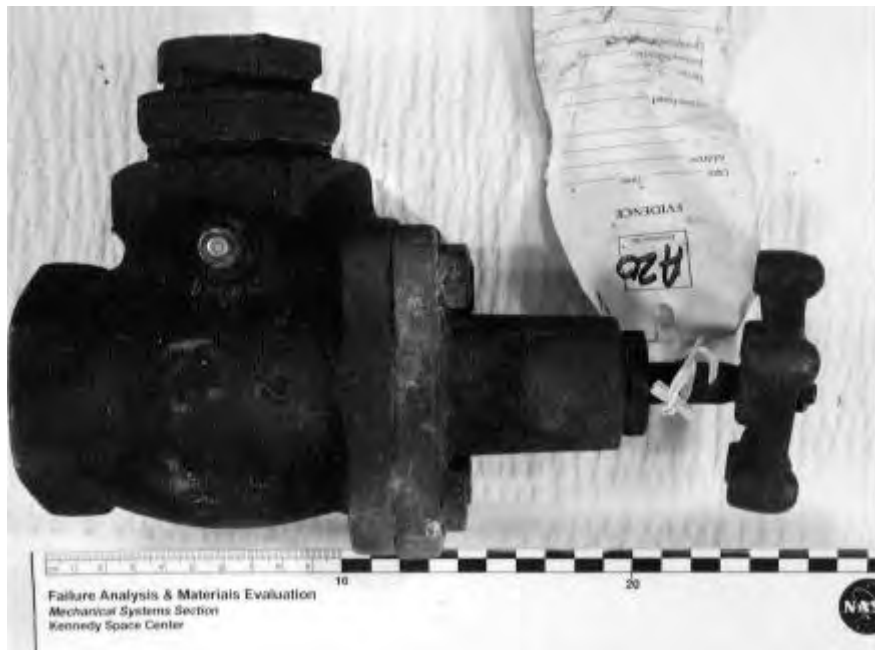
FIGURE 10

observed on other pieces of debris. For example, the shut-off valve (A20) exhibited a number of abrasions that likely occurred as a result of the explosion. As Figure 29 in Appendix B shows, the A1 piece was not dented or damaged. Finally, eyewitness reports of fire under the north and west end of the tank following the impact of the ATV were consistent with a propane leak in the vicinity of the A20/A1 connection under the tank.

The lower view is the hand valve A20 as-received in the laboratory.

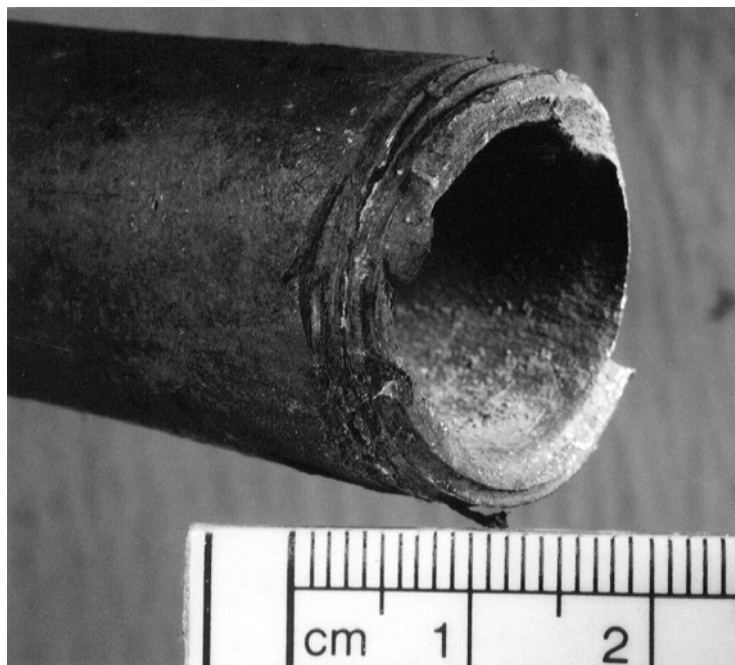
FIGURE 11

Fracture surface of the one inch pipe that previously connected to hand valve A20.

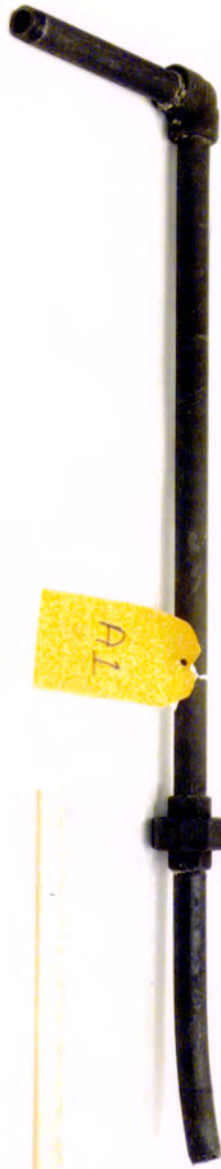
FIGURE 29

View of the pipe that fed liquid propane to the vaporizer units.

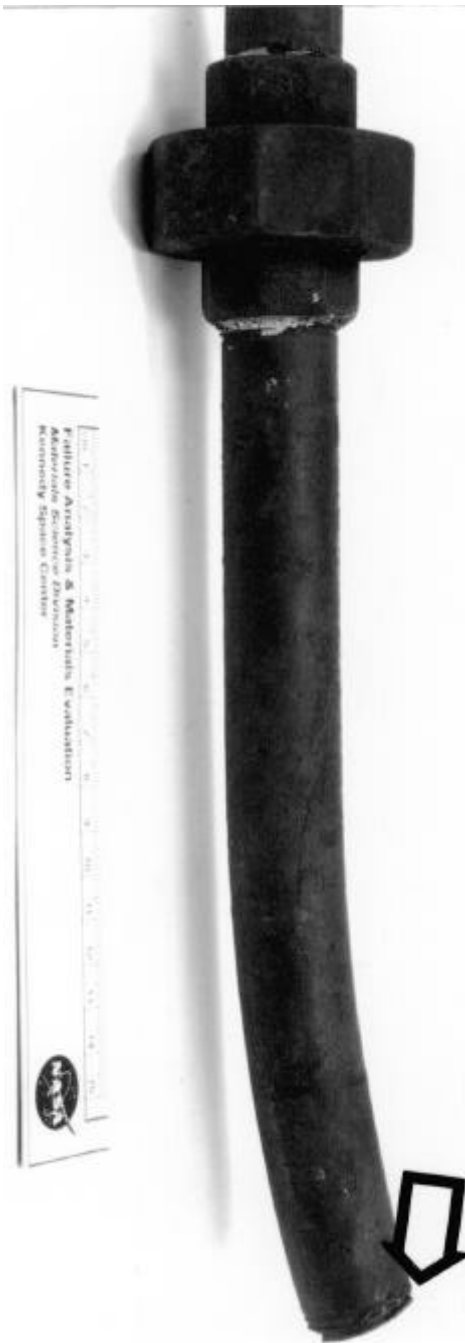
FIGURE 36

View of the end of the liquid propane pipe which fed the vaporizer and mated with the outlet of the hand valve. Note the tube bend and deformation of the threads (arrow).

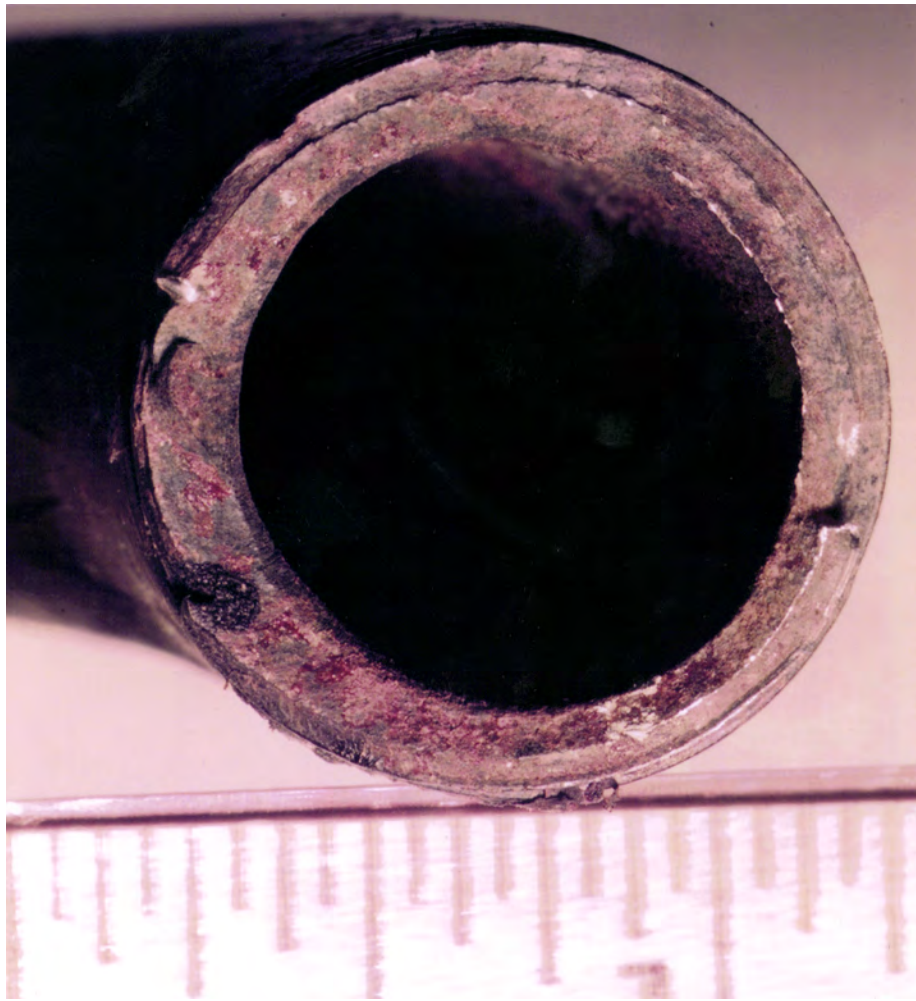
Horizontal stress patterns identified on the edge of the A1 pipe segment that connected to the A20 valve also revealed that the pipe failed in a horizontal plane (see Figure 37, Appendix B). Had the A1 piece been completely connected to the A20 valve at the time of the explosion, these stress patterns would almost certainly have been twisted with a vertical orientation, not a horizontal one. Thus, the force required to produce these stress patterns most likely occurred when the ATV hit the liquid line. The direction of thread deformation on the A1 edge (Appendix B, Figures 36-39) also indicates that the pipe was subjected to a horizontally applied load such as that likely caused by the impact of the ATV.

Figure 37
View of the fracture surface of the one inch pipe (A1) which carried liquid propane to the vaporizer unit

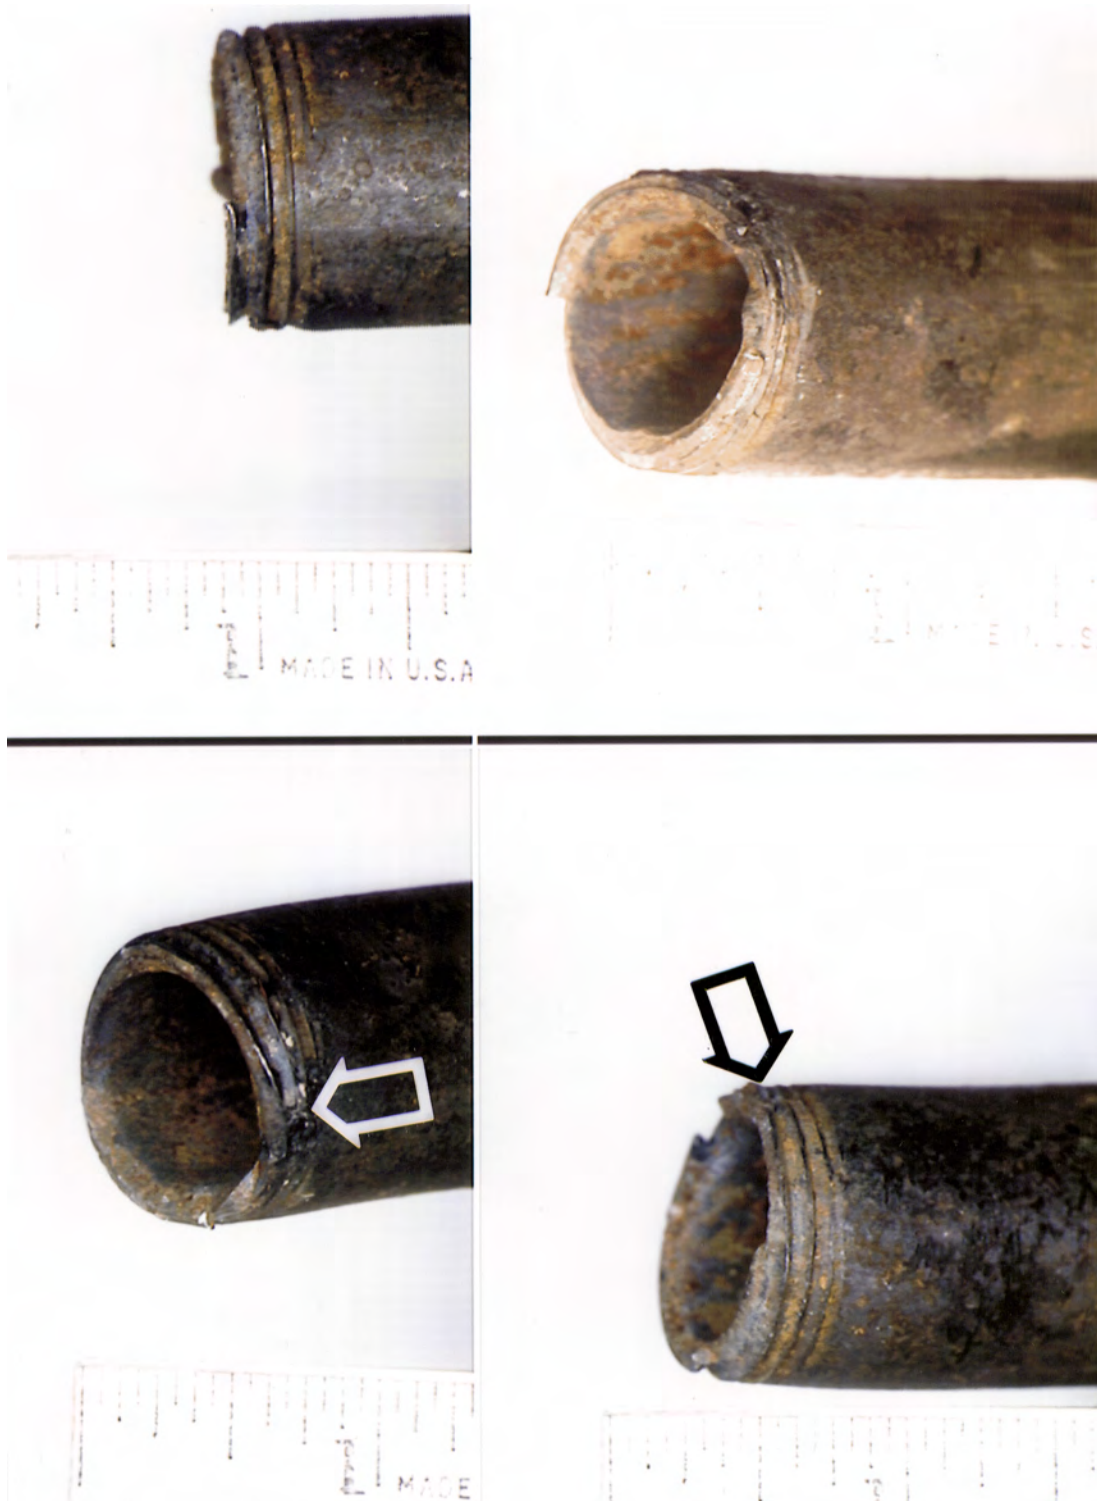
Figure 38

90° rotational view of the threaded end of the one inch pipe (A1). Arrow indicate deformed threads.

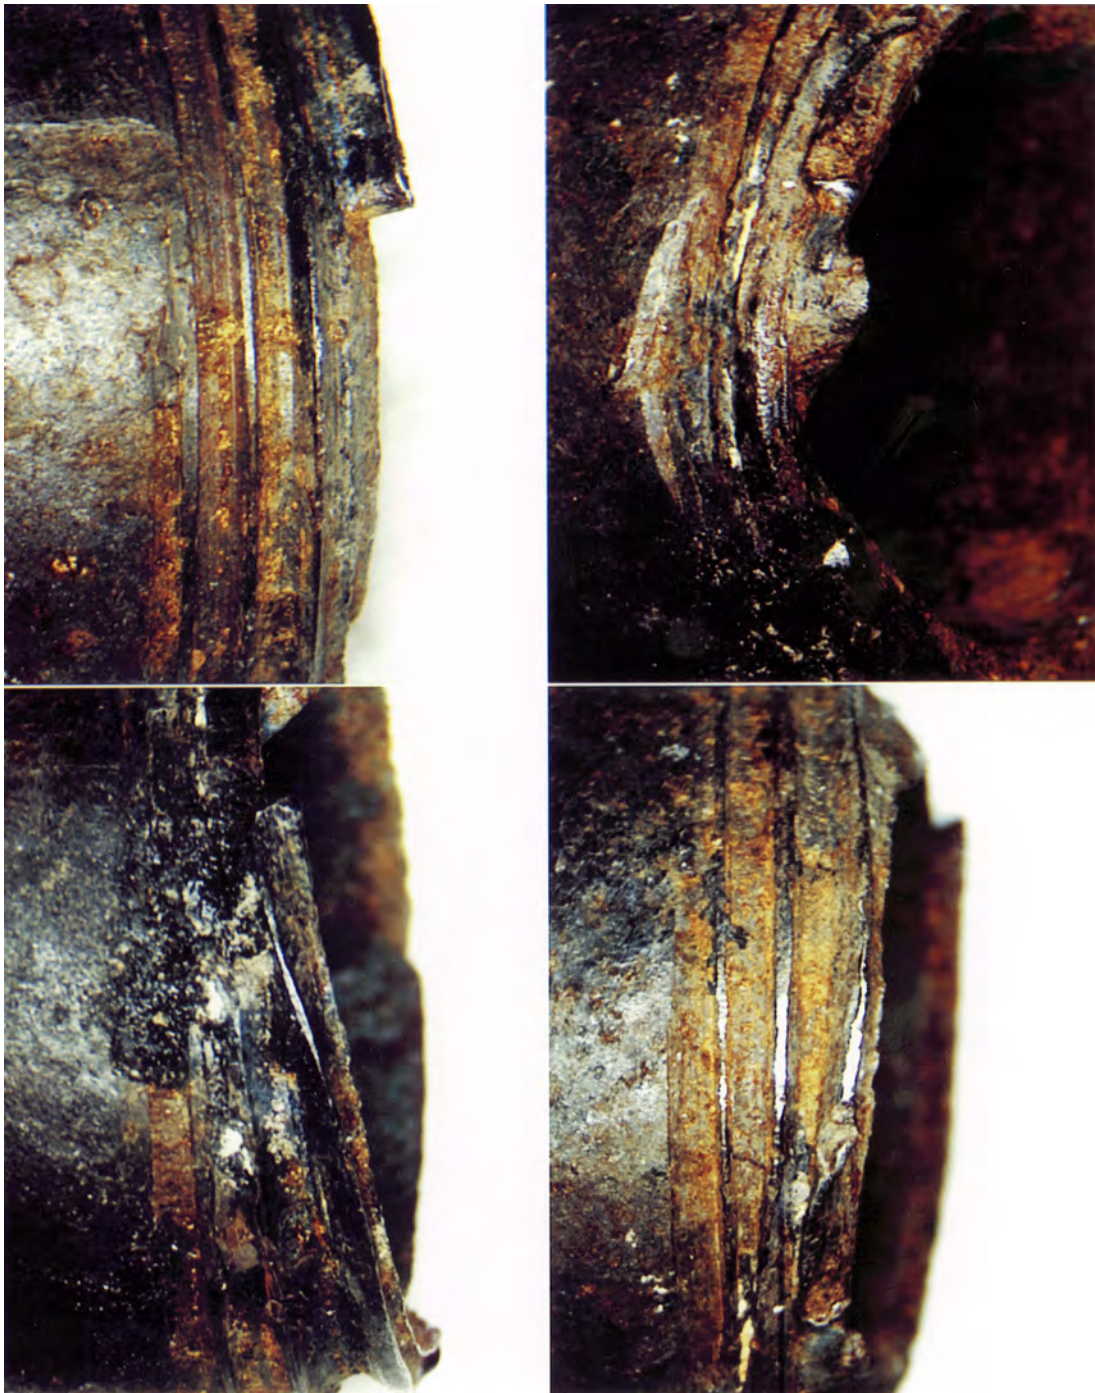
Figure 39
90° rotational view of the condition of the pipe threads on the one inch pipe (A1).
MAGNIFICATION: 5X
