U.S. CHEMICAL SAFETY AND HAZARD INVESTIGATION BOARD

INVESTIGATION REPORT

TOXIC CHEMICAL VAPOR CLOUD RELEASE

MFG CHEMICAL, INC.

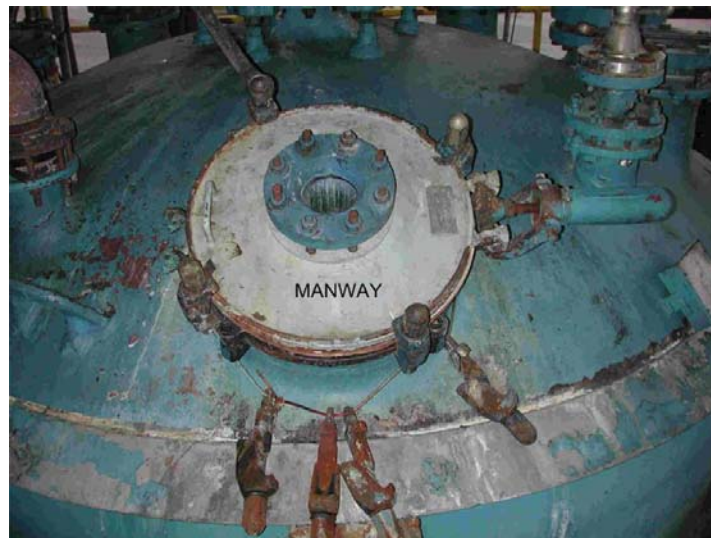
Figure 6. The 18-inch reactor manway.

in a runaway reaction. The increasing pressure blew out the manway gasket, and then the rupture disk. The vapor continued venting for many hours, until the reaction consumed all the reactants.

Tuesday afternoon at 1:00 PM, more than 15 hours after the incident began, the reactor had cooled to 70°F and the reaction appeared to have ended. MFG personnel installed a new rupture disk, replaced the manway gasket, and tightened the clamps. The IC terminated the fire department response activities now that the reactor was resealed.

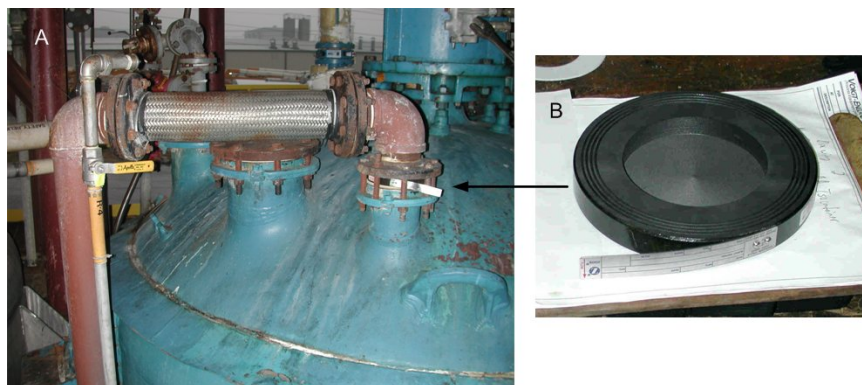
Figure 8. Overpressure rupture disc and vent pipe on top of reactor. An exemplar of the rupture disc (right).

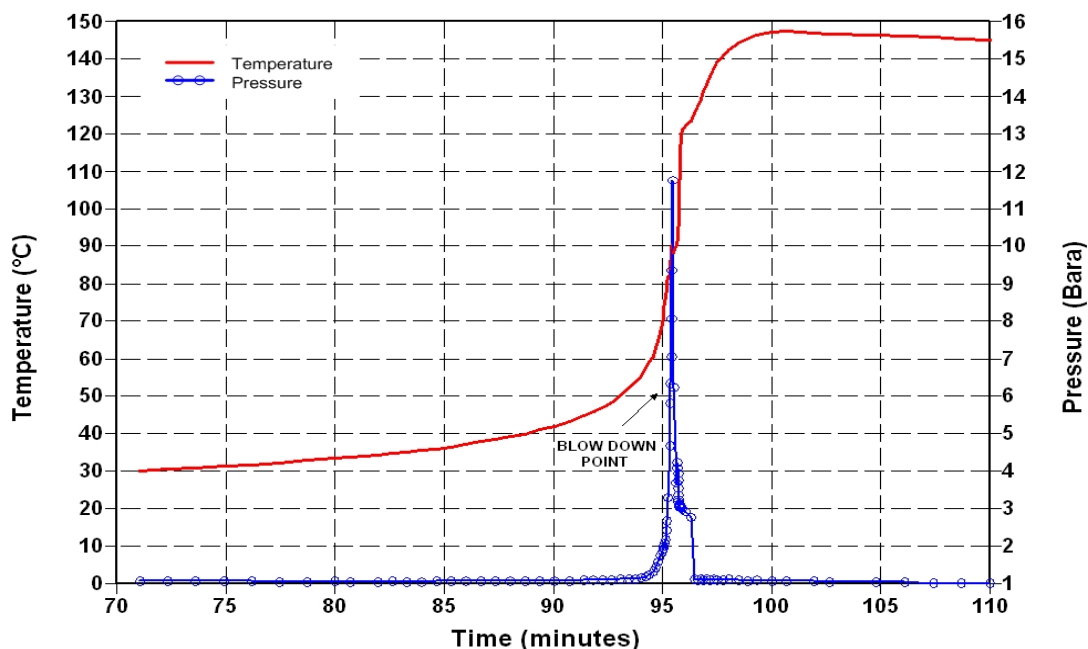
confirmed that the decomposition reaction is highly energetic and capable of causing severe damage to equipment. Appendix A, Table 1 summarizes the test results.

Figure 11. Test cell reaction mass temperature and pressure as a function of time. The blowdown vent opened at six bara (75 psig).

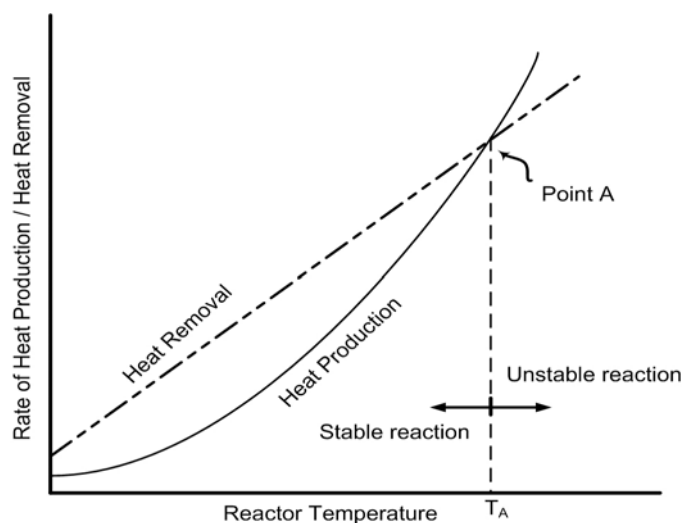
MFG personnel underestimated the heat removal rate required for TAC production because they did not consider either the TAC synthesis reaction or the decomposition reaction when they evaluated reactor cooling requirements. MFG only evaluated the cooling system requirements based on the acid neutralization step that was to occur later in the batch process. Since the procedure did not restrict the chemical addition rates, operators charged the reactor with the entire quantity of each reactant and the catalyst. The cooling system was unable to control the reactor temperature and, as the temperature rose, the decomposition reaction began to dominate, resulting

Figure 12. Typical reaction heat production and cooling system heat removal vs. reactor temperature.

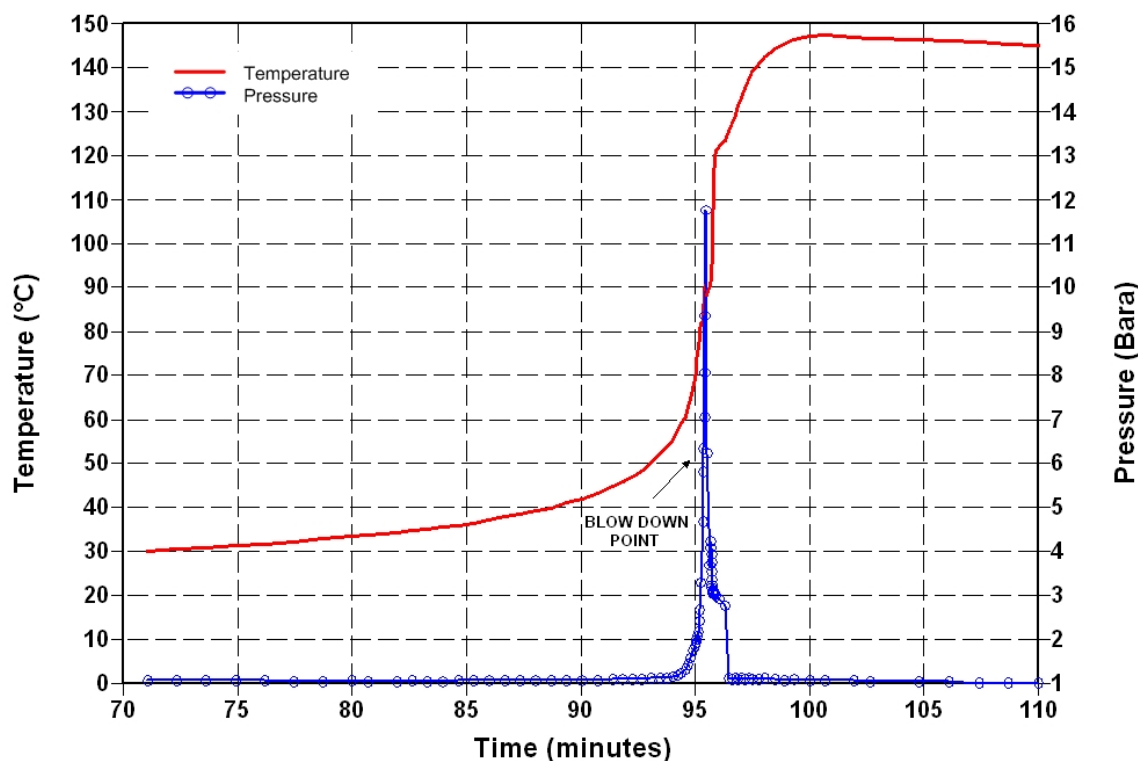
The adiabatic calorimetry testing of the TAC recipe demonstrated the extremely energetic nature of the reaction. The test that simulated the rupture disc opening (Table 1- Low Thermal Inertia, Vented) showed that the reaction progressed very slowly for about 90 minutes, after which the

temperature rapidly increased at a rate exceeding 500 °F/minute (260 °C/minute) with a pressure rise rate approaching 2260 psi/min (155 bar/minute). The test data is presented in Figure 1.

Figure 1. Test cell pressure and temperature for the low thermal inertia, vented at 6 barg (75psig) test.

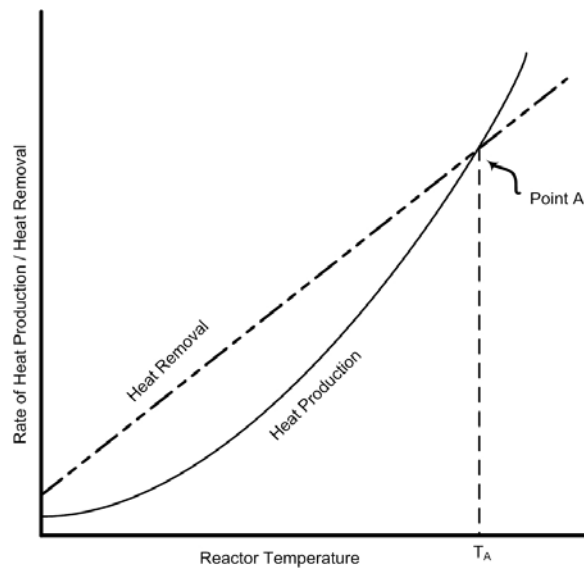
Equations 1 and 2 are shown graphically in Figure 2. If the reaction temperature exceeds the value at point A, the rate of heat production by the reaction exceeds the rate of heat removal provided by the reactor cooling jacket and the reaction will run away.

Figure 2. Heat Generation versus Heat Removal Rate

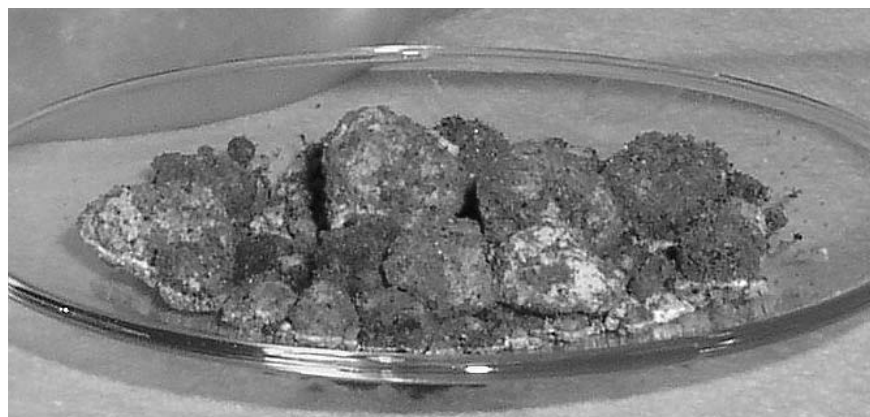
A sample taken from inside the R4 reactor was analyzed both visually and chemically. The material consisted mostly of a white solid interspersed with a small amount of granular black material (Figure 3). The black material could be elemental carbon arising from a high temperature event, such as a thermal runaway, or auto-ignition of allyl alcohol during the final stages of the runaway reaction. Auto-ignition of the allyl alcohol was possible because the maximum

temperature reached during the lab experiments of the allyl alcohol/cyanuric chloride runaway reaction was 425 °C, which exceeds the reported auto-ignition temperature of allyl alcohol (375 – 378 °C). Chemical analysis of the sample, by GC/MS, was not successful due to insolubility of the material.

Figure 3. Residue removed from the reactor after the runaway reaction.

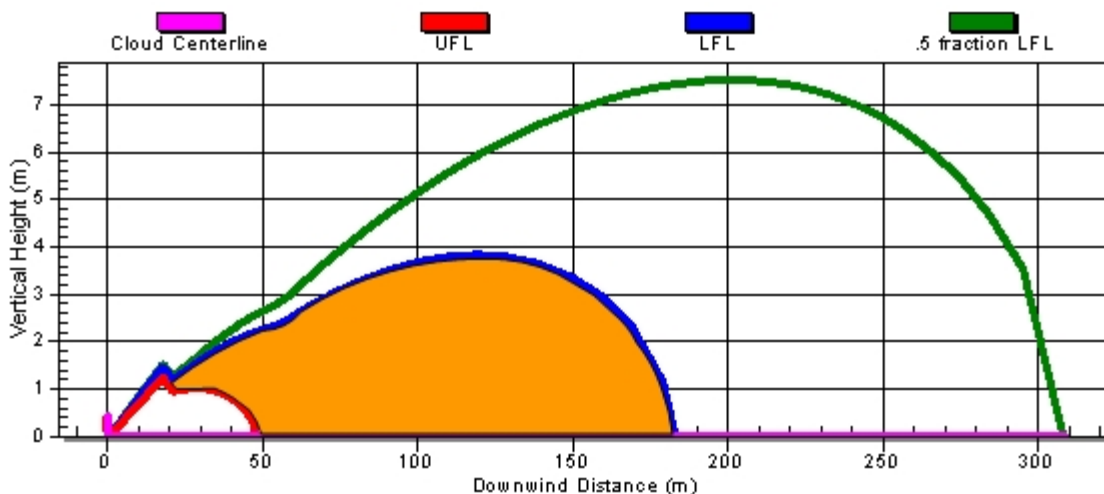
The upper and lower flammable limits for the mixture released from the reactor were calculated using LeChatelier's rule. Figure B-2 is the side-view plot of the vapor cloud rupture disc release concentration limits. The flammable concentration profiles used a 15-second averaging time, essentially the instantaneous concentration in the plume. The model predicted that the flammable range occurred between 50 and 180 meters (164 and 591 feet) from the release (shaded area in Figure 2).

Figure 2. Plume Side View Plot of Rupture Disc Release

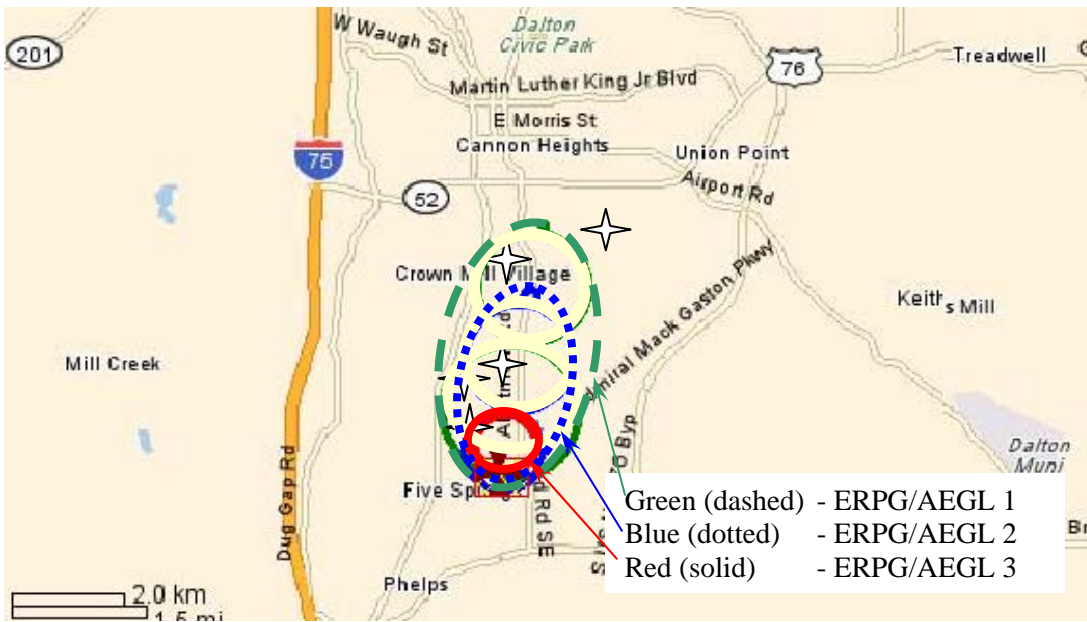
Figure 3 shows the hazard zones for the weighted average contour values for the rupture disc vent release. The stars indicate locations where people exposed to the toxic vapor made calls to the Dalton 911 call center.

Figure 3. Predicted hazard zones for the rupture disc release.

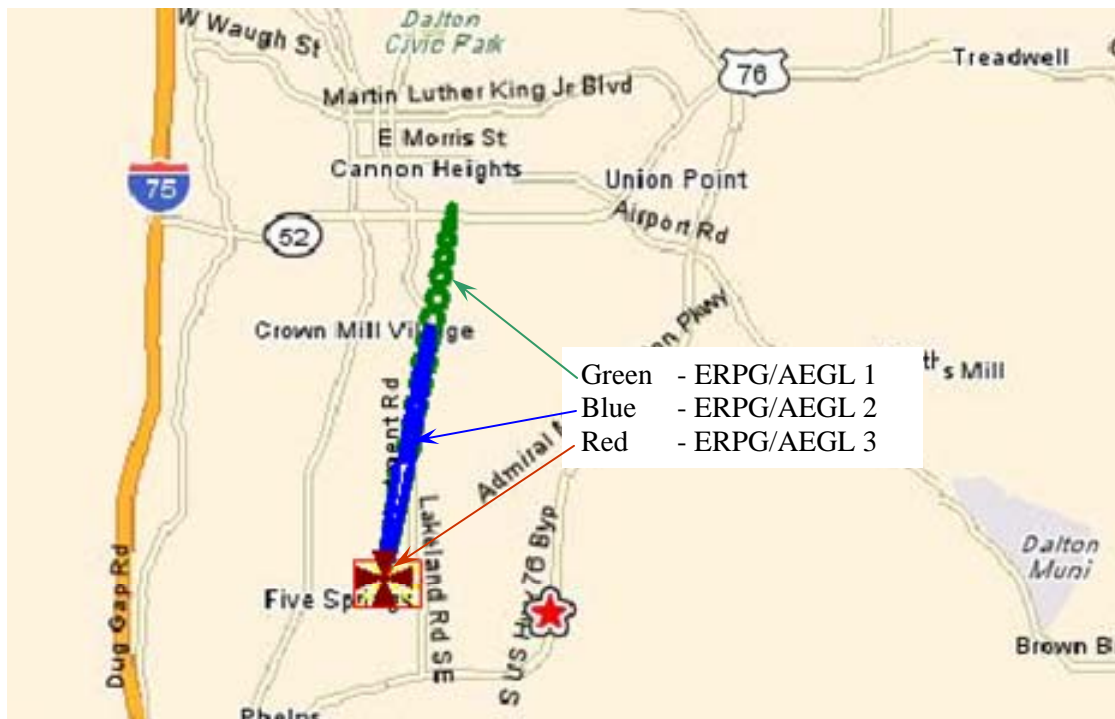
Figure 4 shows the hazard zones for the weighted average contour values for the manway gasket release. Although the manway discharge is a weaker source and the predicted dispersion is low, the small puff extends a considerable distance due to the low wind speed (approximately one meter/second) during the release. However, in dispersion prediction uncertainty increases as wind speeds decrease below about three meters/second.

Figure 4. Predicted hazard zones for the manway gasket release.
