U.S. CHEMICAL SAFETY AND HAZARD INVESTIGATION BOARD

INVESTIGATION REPORT

LPG FIRE AT VALERO – MCKEE REFINERY

REPORT NO. 2007-05-I-TX

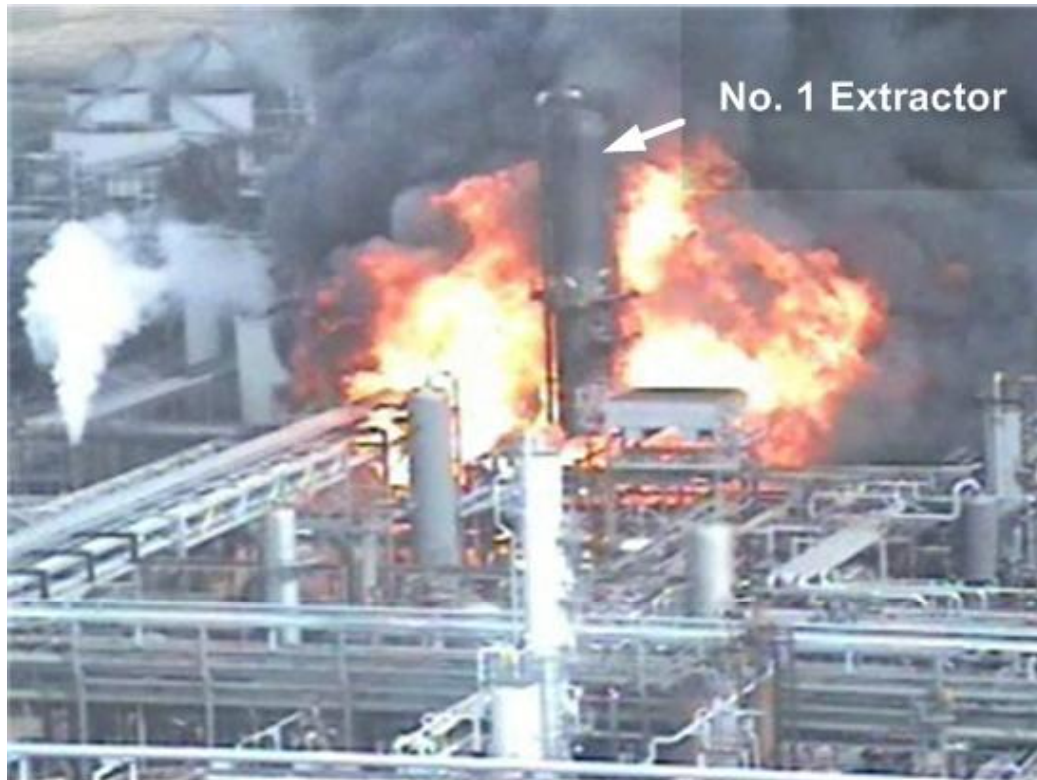
Figure 3. Approximately 90 seconds after ignition (from surveillance video)

The propane escaping from the high-pressure system formed a vapor cloud that traveled downwind toward the boiler house, where it likely ignited.¹¹ The flames flashed back to the leak source.

A steel support column on the east/west (E-W) pipe rack was impacted by a high-pressure propane jet fire. The column, which was not protected by fireproofing insulation, buckled, collapsing the rack and causing multiple pipe failures. Liquid petroleum products discharged from the damaged pipes, contributing to the rapid spread of the fire and the damage caused to surrounding equipment, such as the No. 2 Cooling Tower and No. 4 Naphtha Column.

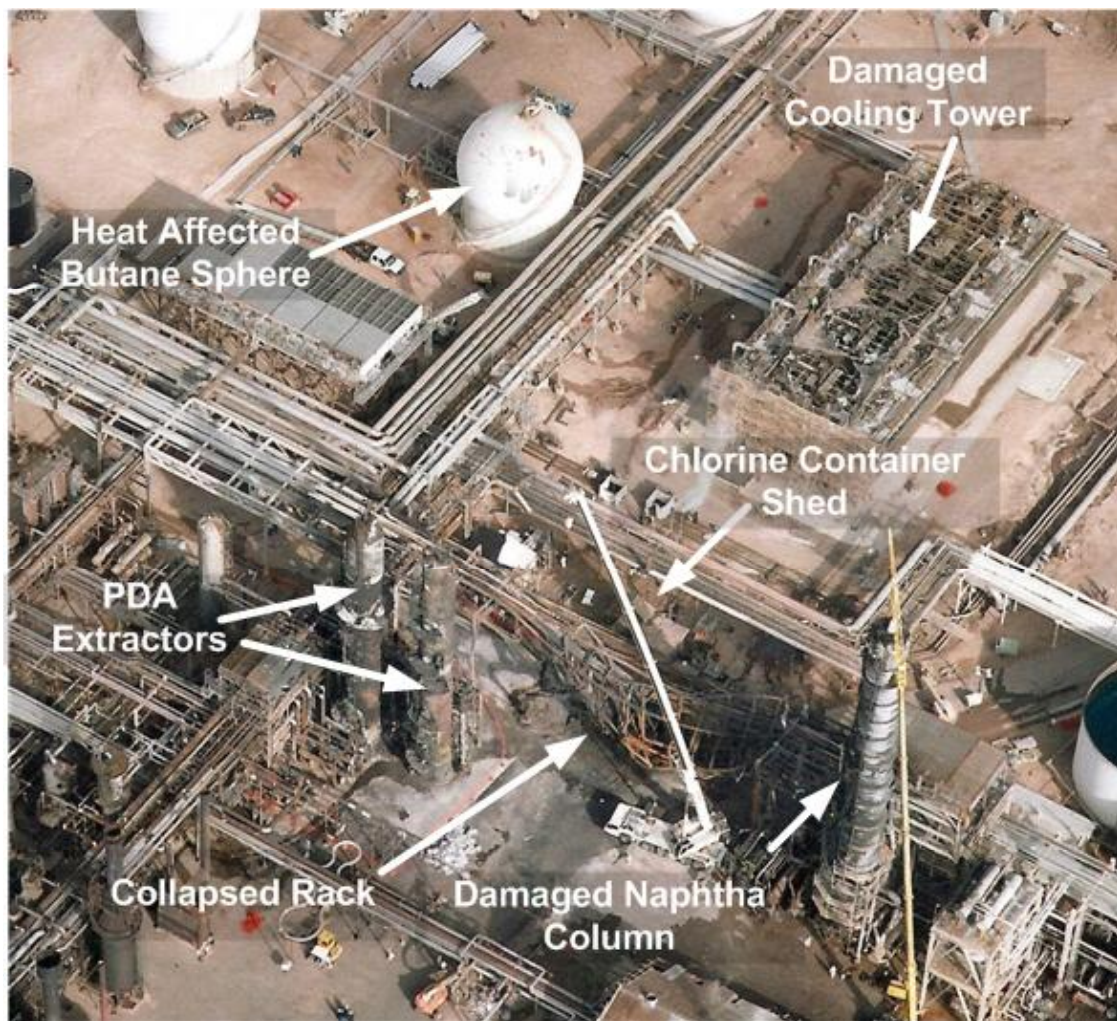
Figure 4. Aerial photograph of damage from the PDA unit fire

The PDA unit was heavily damaged (Figure 4). Much of the piping, control wiring, and heat exchange equipment in the area of the extractors was destroyed and major equipment items, including the extractor towers, required extensive evaluation to determine if they were safe for continued use. Valero restarted the rebuilt PDA unit in January 2008, nearly one year after the fire, restoring the refinery to full production capacity.

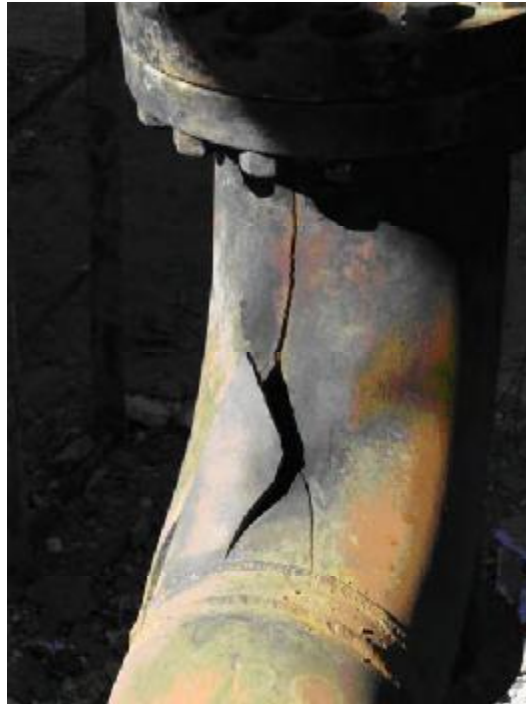
Figure 6. Crack in the 10" diameter propane mix control station inlet elbow

The station's configuration made it a dead-leg: a section of piping connected to the process with no flow through it. Water in the propane likely sank into the dead-leg, leaked by the inlet block valve, and accumulated in the control station piping.²⁴

The extended period of cold weather and the lack of freeze protection on the control station allowed the water to freeze and expand, cracking the elbow upstream of the control valve. The crack propagated along the inner radius of the elbow, the line of highest stress (Timoshenko, 1958), opening wider as it developed (Figure 6). Appendix C contains a more detailed discussion of the CSB's analysis of crack formation and propagation. The damage to the inlet elbow and the post-incident leak rate determined for the inlet block valve are consistent with the estimated initial propane release rate during the incident.

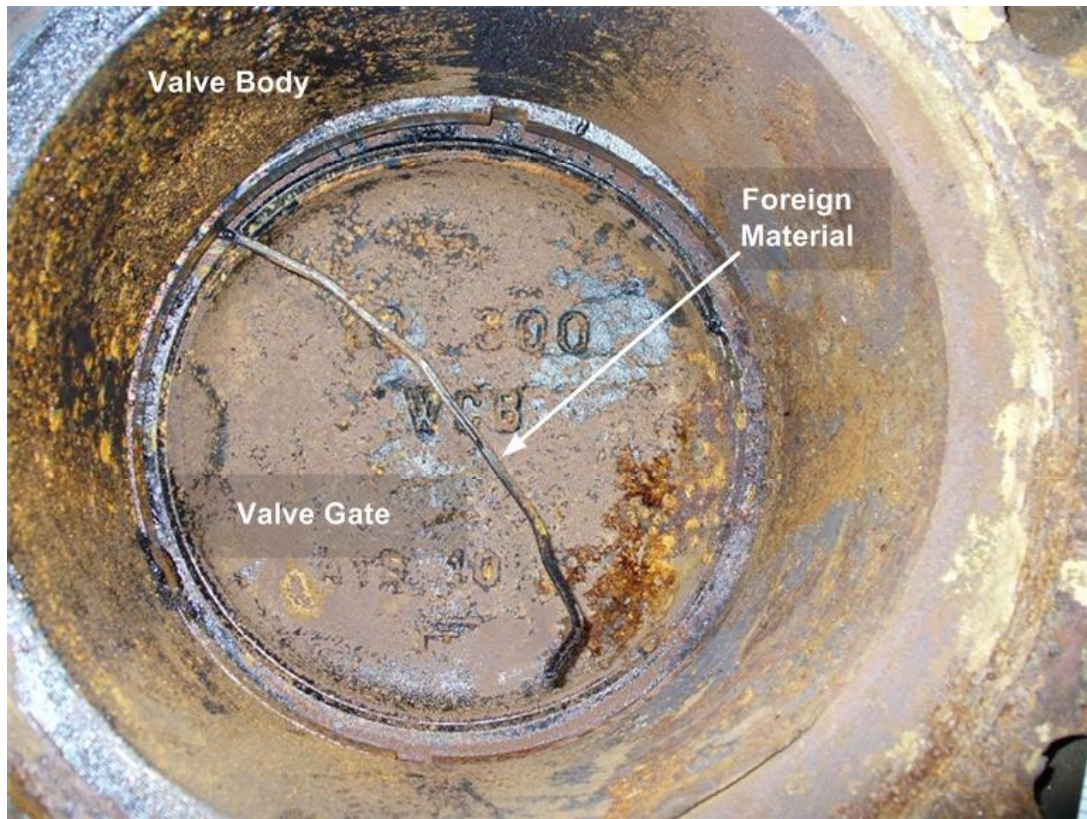
Figure 7. Downstream view of propane mix control station inlet block valve

On February 16, 2007, shortly after 9:00 a.m., ambient temperatures rose above freezing and the ice inside the elbow began to thaw. Post-incident examination of the control station inlet block valve (Figure 7) revealed that a foreign object was jamming the valve,²⁵ creating a leak path. When tested in a laboratory after the incident, this valve allowed over 1,025 gpm (233 m³/hour) of water to leak through at process pressure. At approximately 2:09 p.m., melting ice opened the leak path, releasing liquid propane at 500 psig (3,447 kPa) pressure through the cracked elbow. A flammable vapor cloud rapidly formed. Based on recorded data from the PDA unit's computerized control system, the CSB estimated an initial propane leak rate of 4,500 pounds (2,040 kg) per minute (Appendix D describes the propane mass balance calculations used to develop this figure).

²⁵ In gate valves, a circular gate slides against metallic seat rings, providing a leak-tight seal when the valve is closed. The foreign object in the inlet gate valve prevented a tight fit between the gate and the seat rings.

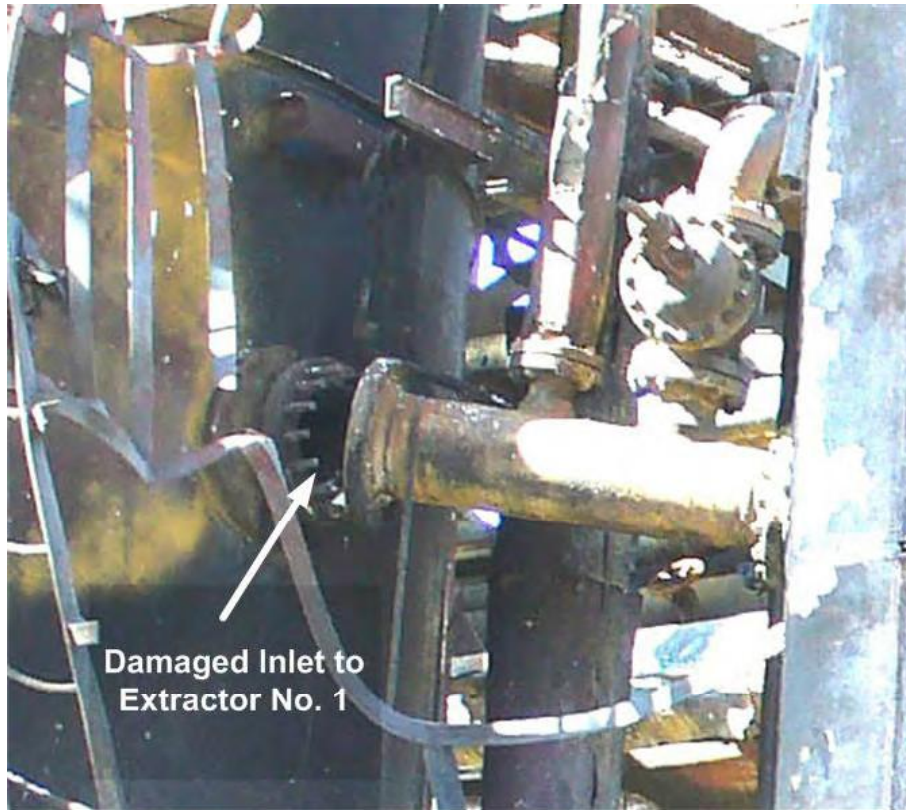
Figure 8. Damaged 10" propane inlet on Extractor No. 1

The wind blew the propane cloud toward the boiler house, where it likely ignited.²⁶ The flames flashed back to the release point. The size and intensity of the resulting fire blocked access to manual shut-off valves and pump on-off switches that might otherwise have been used to control the propane discharge. Within minutes, the fire damaged piping and pipe rack supports, spreading the fire (Figures 4, 8, 9).

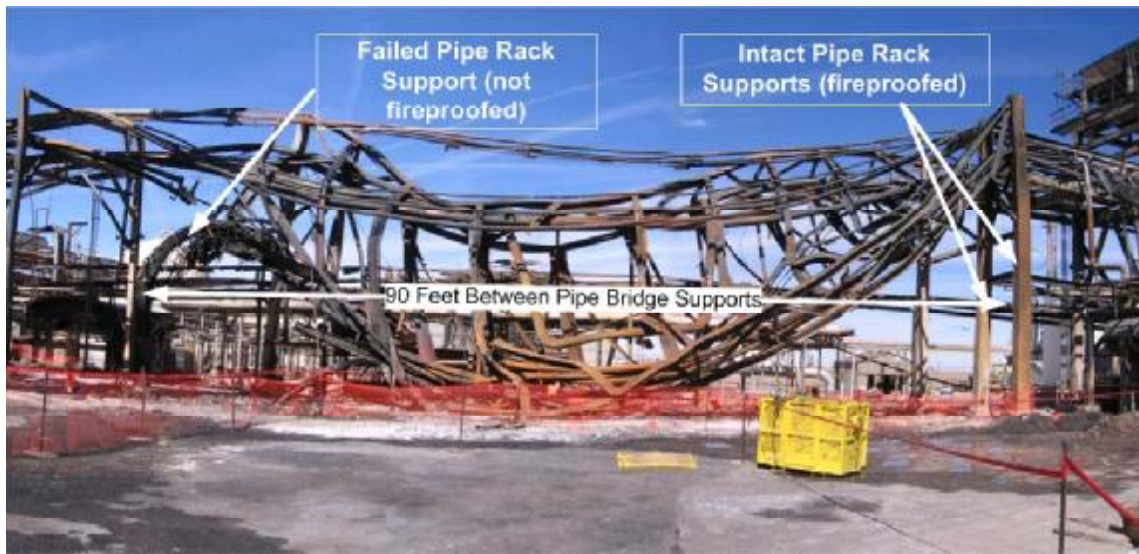
Figure 9. Pipe bridge support fireproofing

A non-fireproofed structural support for a pipe bridge³³ spanning a 90-foot wide open area north and east of the PDA unit (Figure 9) collapsed early in the incident, greatly increasing the magnitude of the fire. The support was located on a major E-W pipe rack north of the unit, outside the fireproofing distances recommended by API guidance and Valero internal standards. The collapse opened multiple lines carrying flammable and combustible materials from other areas of the refinery, contributing significantly to the damage experienced by adjacent units, and extending the time that the refinery was down for repairs. Fireproofed pipe rack support steel columns inside the PDA unit and at the No. 4 Naphtha Column all survived the fire without collapsing (Figure 10).

Valero Energy Corporation's SP-00-04, *Fire Proofing Specifications*, calls for fireproofing pipe racks within 30 feet of equipment with the potential to cause a serious fire, but makes no special provisions for processes handling LPG. A loss-prevention report produced for the McKee Refinery listed fireproofing of pipe rack support steel, including the E-W pipe rack north of the PDA unit, as a top priority for the site fireproofing program, but the rack had not been fireproofed at the time of the incident.

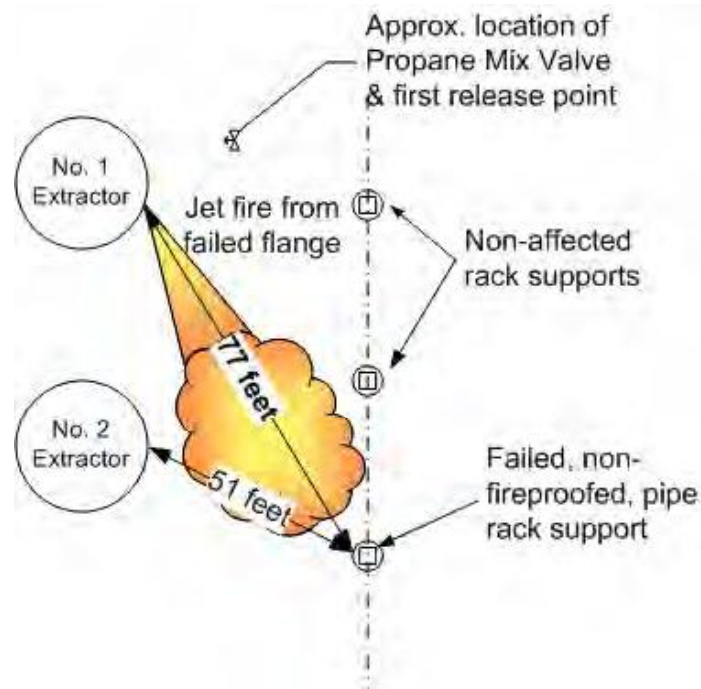
Figure 11. Distances between the E-W pipe rack supports and the extractors

A failed inlet flange to the No.1 Extractor, located 77 feet away from the buckled pipe bridge support, was the most likely source of the jet fire that collapsed the pipe bridge (Figure 11). The closest major process vessel (the No. 2 Extractor) was 51 feet away from the support. These distances exceed both API's and Valero's recommended fireproofing distances.

API 2218 references the API 2210/2210A LPG fireproofing distance of 50 feet, developed for pool fires in LPG storage units. Neither standard addresses fireproofing for LPG processes or jet fire scenarios, even though process unit conditions, including pressure, can be more extreme than those found in storage facilities. In this incident, the high operating pressure of the extractors (500 psig, 3,447 kPa) likely produced a jet fire with a range and intensity beyond that anticipated in the API standards for LPG storage releases.

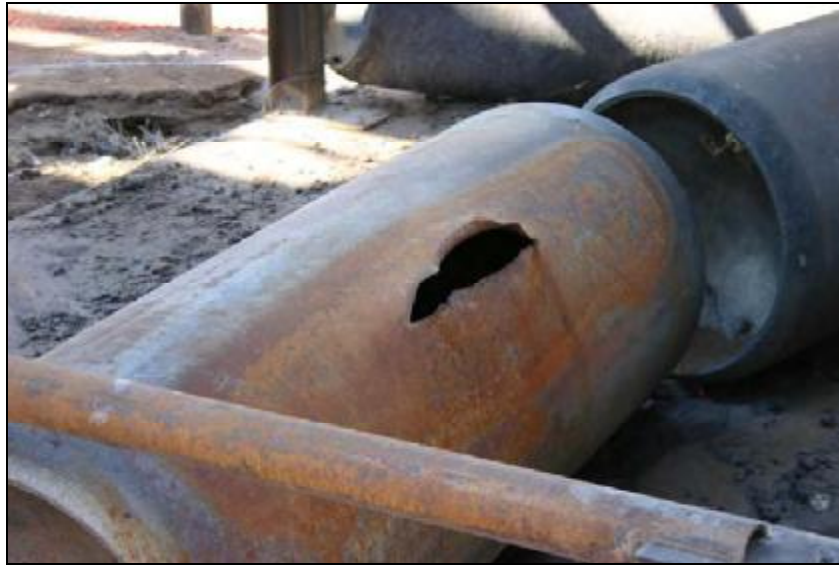
Figure 13. Ruptured one-ton chlorine container

Post-incident examination revealed that three one-ton chlorine containers in a cooling tower water treatment shed were subjected to radiant heating due to their proximity to the PDA unit (100 feet to No. 2 Extractor) and pipe rack (20 feet). All three containers vented when their fusible plugs, installed to prevent container rupture, melted as designed. One container ruptured despite the operation of its fusible plugs, and another vented completely. The third developed a leak through a partially melted plug that was repaired by emergency responders using self-contained breathing equipment for protection against the toxic vapor. More than 2.5 tons of chlorine, an extremely toxic material, were released.¹⁸

Safer materials for controlling biological growth in cooling towers are available, and Valero has identified replacing chlorine in cooling water treatment at all its refineries as a safety goal in its 2008-2012 Strategic Plan. The plan noted that 10 of its 18 refineries (as of May 2007) used ton container quantities of gaseous chlorine as a cooling water biocide. The McKee Refinery substituted sodium hypochlorite (bleach) for chlorine in its No. 2 Cooling Tower during PDA unit reconstruction. Bleach essentially stores chlorine in a form that presents a much lower inhalation hazard, an example of the inherently safer principal of attenuation (Kletz, 1998).^{49, 50}

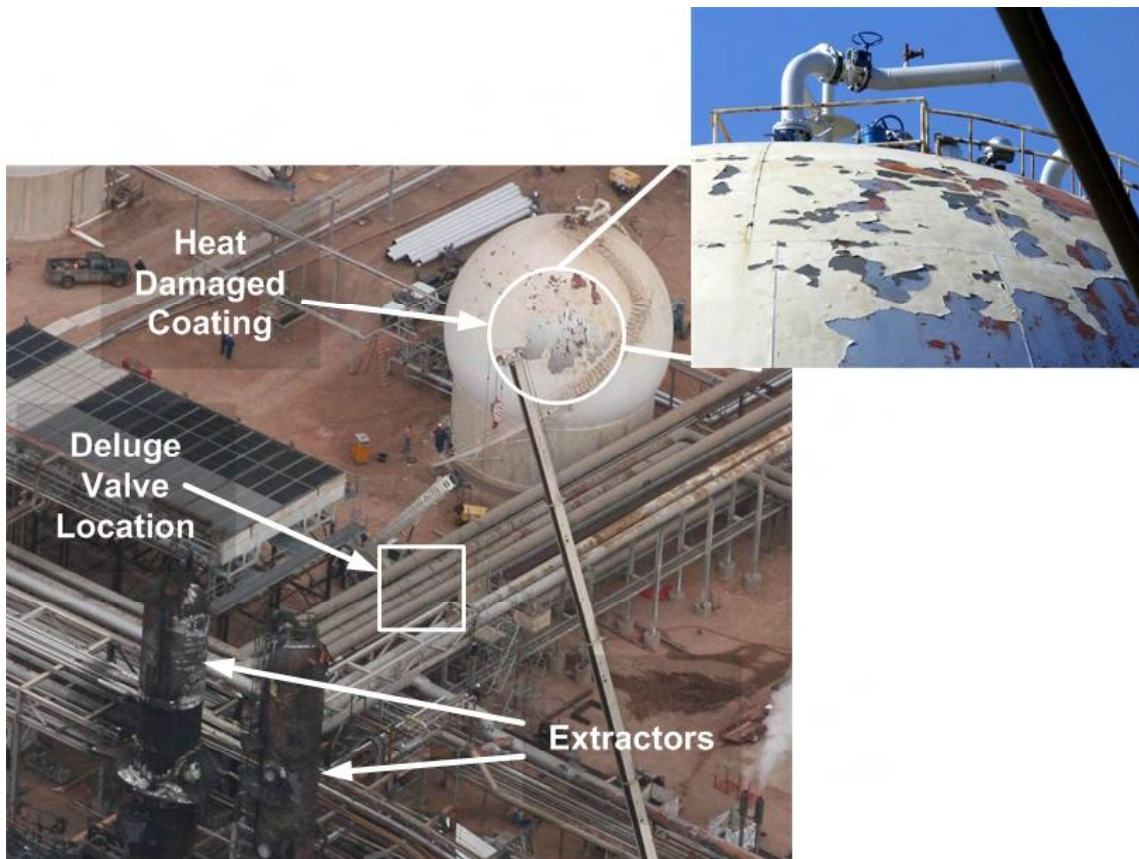
Figure 14. Heat-damaged coating on sphere and location of sphere deluge valves

approximately 3,600 barrels (151,000 gallons, 572 m³) of liquid butane under pressure, and was exposed to radiant heat from the fire. Figure 14 shows heat damage to the white protective coating on the tank's exterior.

Analysis of the overall effects of the fire revealed significant vessel damage as far as several hundred feet away from the PDA unit, generally downwind from the initial release, and including the insulated No. 4 Naphtha Column. Although the wind shifted several times during the fire, it never blew strongly from the southeast, which would have directed the flames toward the uninsulated butane sphere. Exposure to direct flame impingement or to significant heating over a prolonged period might have resulted in a vessel failure with potentially catastrophic consequences.

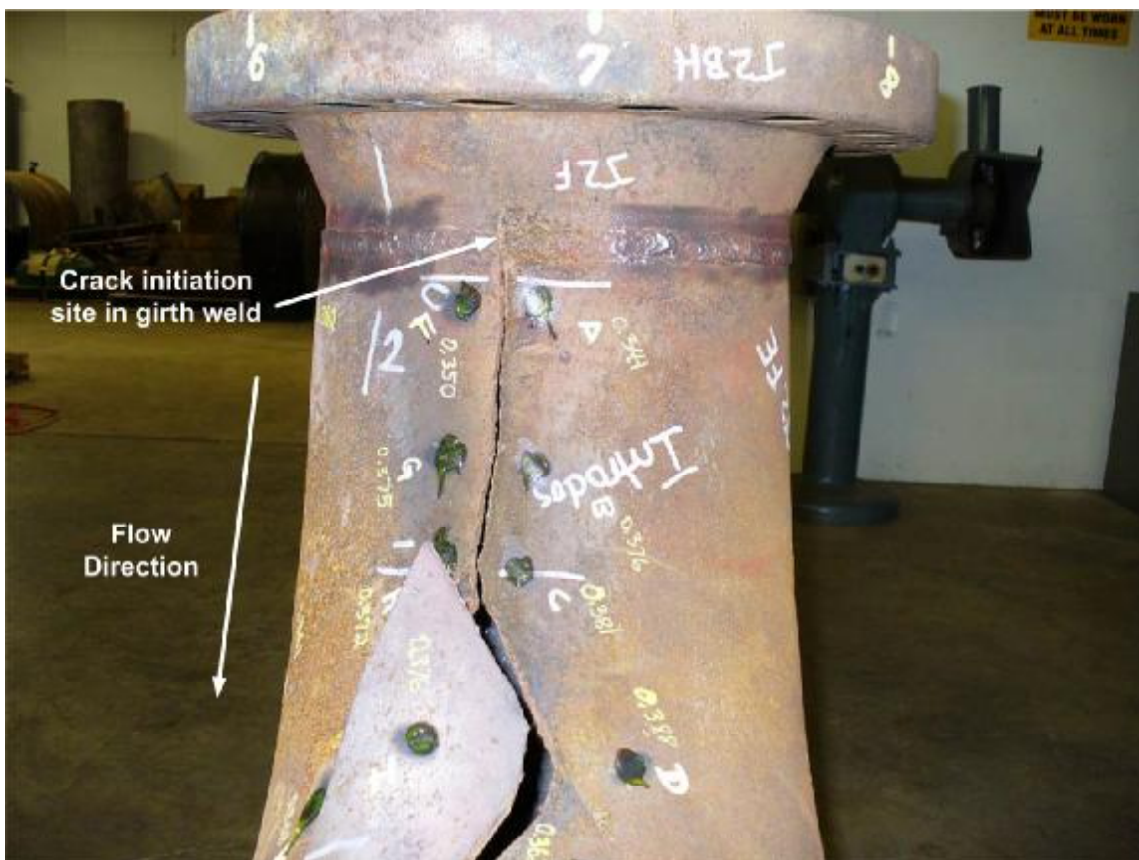
Figure C- 1. Fractured inlet elbow

The fracture in the inlet elbow of the No. 1 Extractor propane mix control station initiated in the exterior surface (cap) welding pass of the girth weld that joined the 10" NPS inlet flange to the 10" elbow, on the intrados (the inner radius) of the elbow (Figure C- 1). No flaw was observed at the initiating site, and the elbow and flange materials were within specification for tensile properties and chemical composition.¹

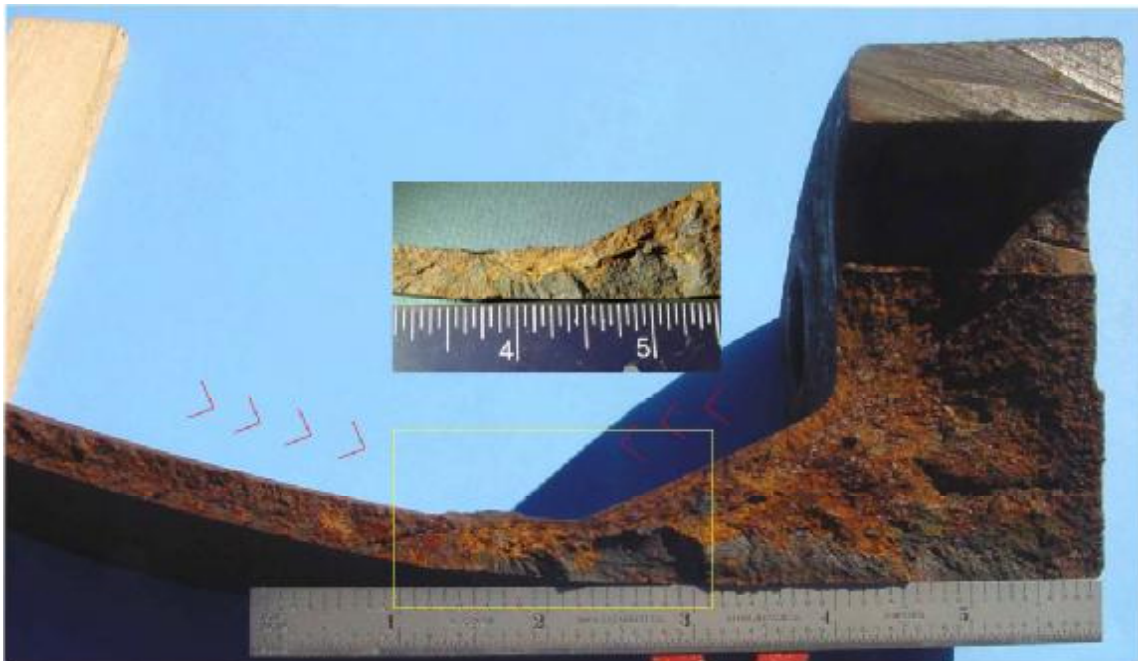
Figure C- 2. Origin and brittle propagation markers

The fracture propagated parallel to the pipe axis in both directions, with the surface exhibiting brittle fracture propagation features (Figure C-2).

Charpy V-notch (CVN) toughness tests were performed on the elbow and flange materials. Based on a 50 percent shear-area appearance, ductile to brittle transition temperatures were determined to be 95°F and 70°F (35°C and 21°C), respectively. Given that this piping was exposed to temperatures as low as 6°F (-14°C), brittle propagation behavior could be expected in these components.
