U.S. Chemical Safety and Hazard Investigation Board

AL Solutions, Inc., New Cumberland, WV Metal Dust Explosion and Fire

December 9, 2010

No. 2011-3-I-WV

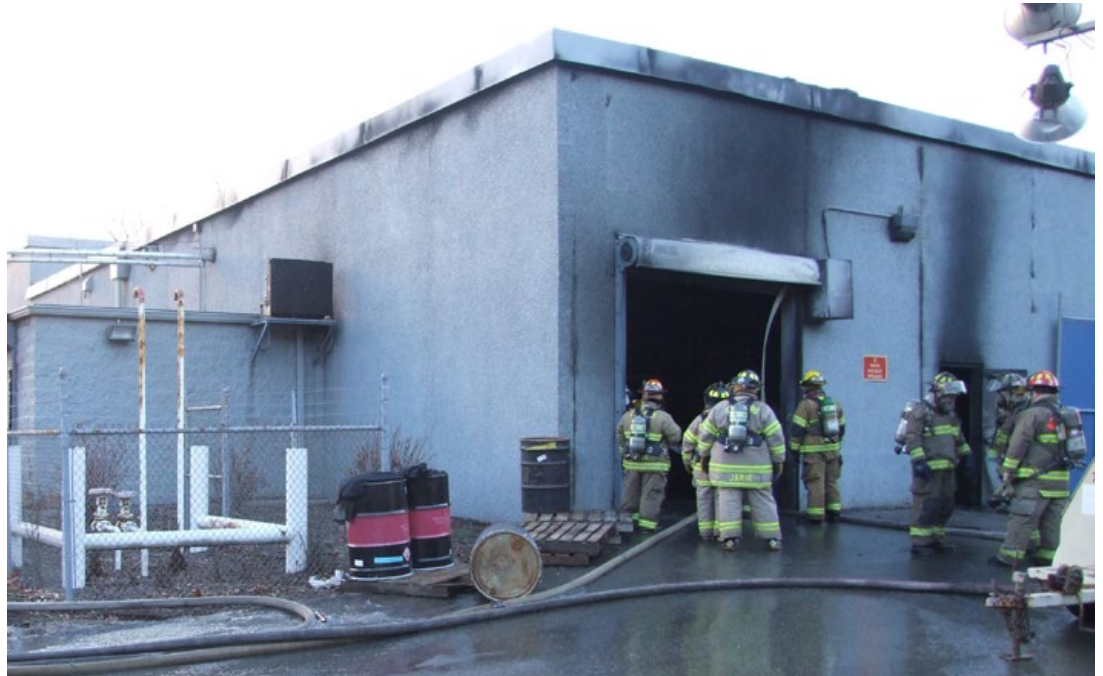
FIGURE 5

Production Building Exterior, with Firefighters on Scene (photograph courtesy of the New Cumberland Police Department).

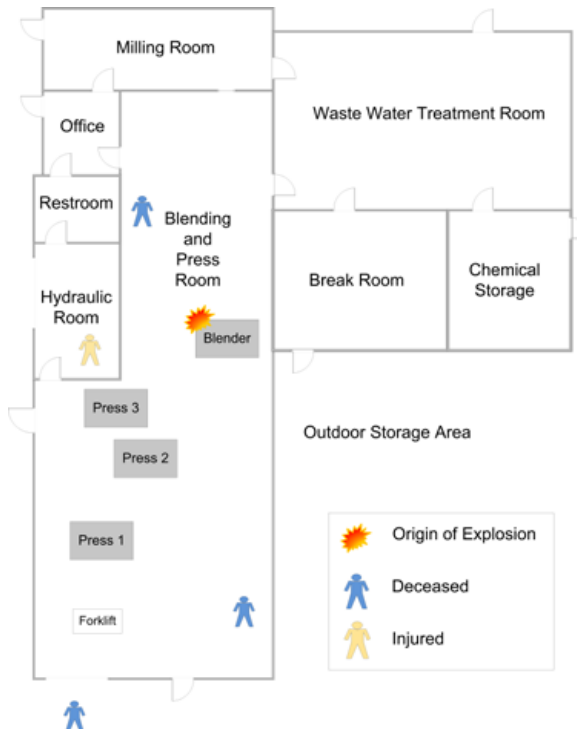
FIGURE 6

Main Production Building Layout, Likely Initiation Point of the Incident, and Worker Injury and Fatality Sites

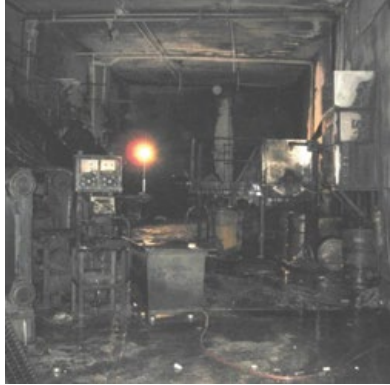
FIGURE 7 (LEFT)

North End of Blending
and Press Room

On the basis of production operations at the time of the incident, the blender likely contained a substantial quantity of zirconium. Indications of burned residue and char on the ceiling above the blender (shown in Figures 7 and 8) and the presence of burning deposits on the wall behind the blender suggest that the burning zirconium particulates lofted from the blender after the initial explosion, engulfing the room in fire. After the incident, the blender lid, intended to be closed during production, was found left in the open position. The scraping of the blender blades against the sidewalls of the blender likely ignited the zirconium powder early in the incident sequence. The cloud of combustible zirconium resulted in a deflagration.¹⁵ Hot gases expanded, producing the “woof” or “wind” observed by two witnesses. The burning zirconium dust cloud also ignited open drums and tubs of titanium and zirconium at several locations in the production building, propagating the fire.

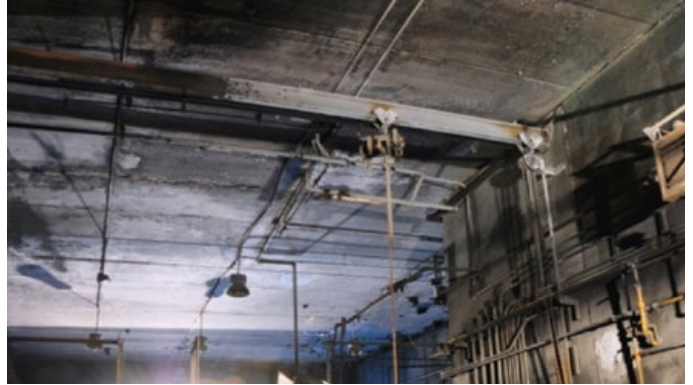
FIGURE 8 (RIGHT)

Ceiling in Blending and
Press Room

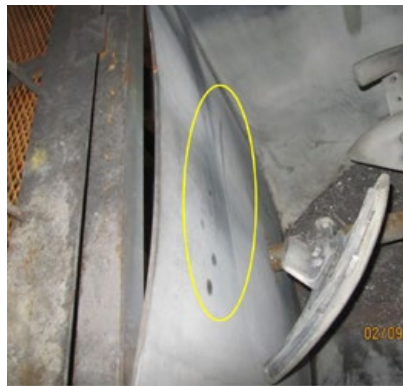
FIGURE 10 (LEFT)

The pre-explosion sound of metal failure or popping reported by AL Solutions employees likely originated in the blender, which showed evidence of the most substantial metal deformation after the incident. Both endwalls were deformed inward and had visual indications of the blade scraping or scoring on the wall (Figure 10). Residual burned zirconium was detected in the blender beneath the shaft. Severe burn damage was also seen in the press on the other side of the production room (shown in Figure 11) and there

Zirconium Blender Wall Deformation and Scoring (circled)

blender and scoring the housing. To address these problems, maintenance personnel adjusted the blender blades to increase clearance from the blender wall, but this action did not permanently address the issue with the metal-to-metal contact. When the problem returned, maintenance personnel decided to replace parts of the blender in an effort to resolve the issue. While the operators were disassembling the blender, they discovered a large groove cut in the shaft and an 8-inch to 12-inch crack in the sidewall of the blender, most likely caused by the paddle blades scraping the sidewall. The maintenance worker welded this crack, and operators continued to use the blender.

On the morning of the incident, an operator requested that maintenance replace a worn paddle in the blender. A maintenance employee retrieved a paddle from an old blender and attached it to the blender in the production building about two hours before the incident. All of the maintenance performed on the blender only temporarily addressed the problems caused by the metal-to-metal contact, such as the scoring on the sidewall and worn paddles. AL Solutions did not repair or replace the blender to avoid exposing combustible metal dusts to sparks or heat produced by the mechanical impact from the paddles.

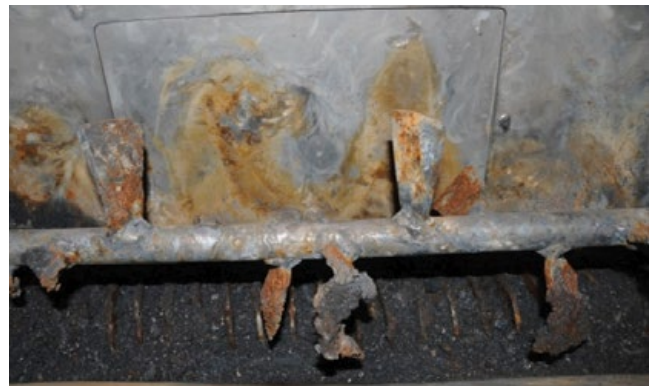
FIGURE 11 (RIGHT)

Press Blade Damage

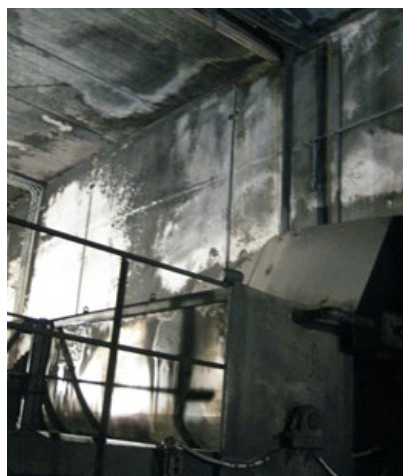
FIGURE 12

Blender and the Adjacent Wall and Ceiling

Investigators examined the production building wall and ceiling adjacent to the blender and found visual evidence of a burning dust cloud projected upward toward the ceiling (displayed in Figure 12).

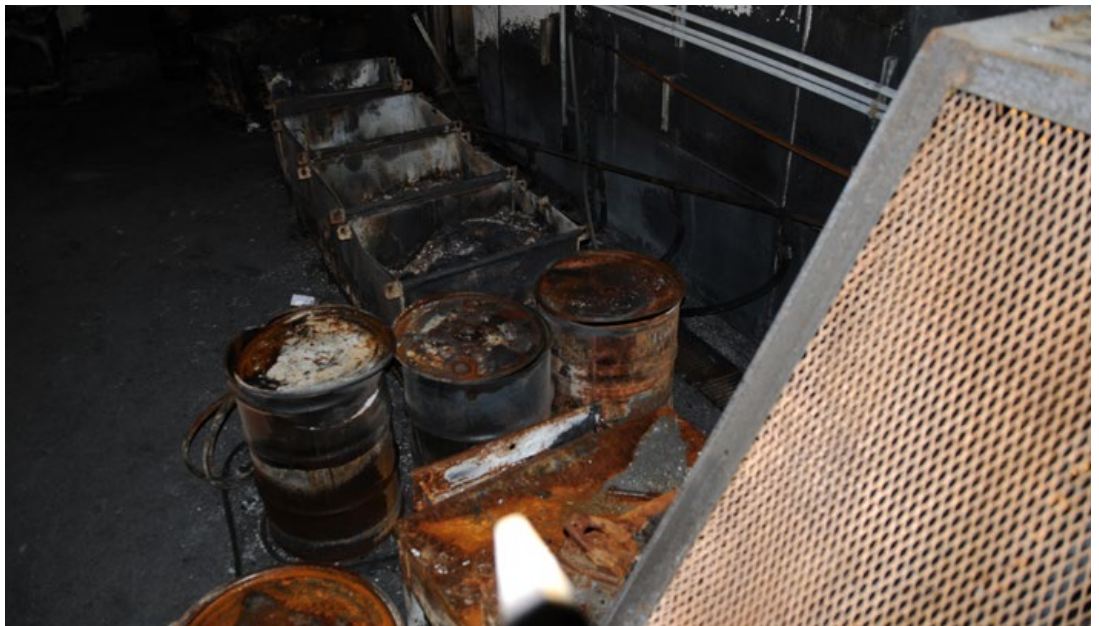
FIGURE 15

Drums of Titanium and Zirconium Particulates near Blender

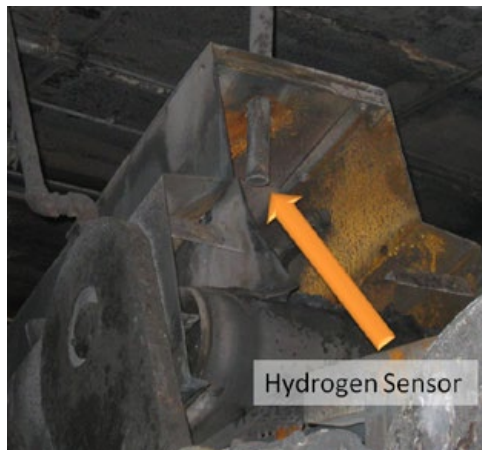
FIGURE 16

Hydrogen Sensing Port
at the Top of the Press
2 and 3 Conveyor Belt
(post incident)
