Williams Geismar Olefins Plant

Reboiler Rupture and Fire
Geismar, Louisiana

Incident Date: June 13, 2013
Two Fatalities, 167 Reported Injuries
No. 2013-03-I-LA

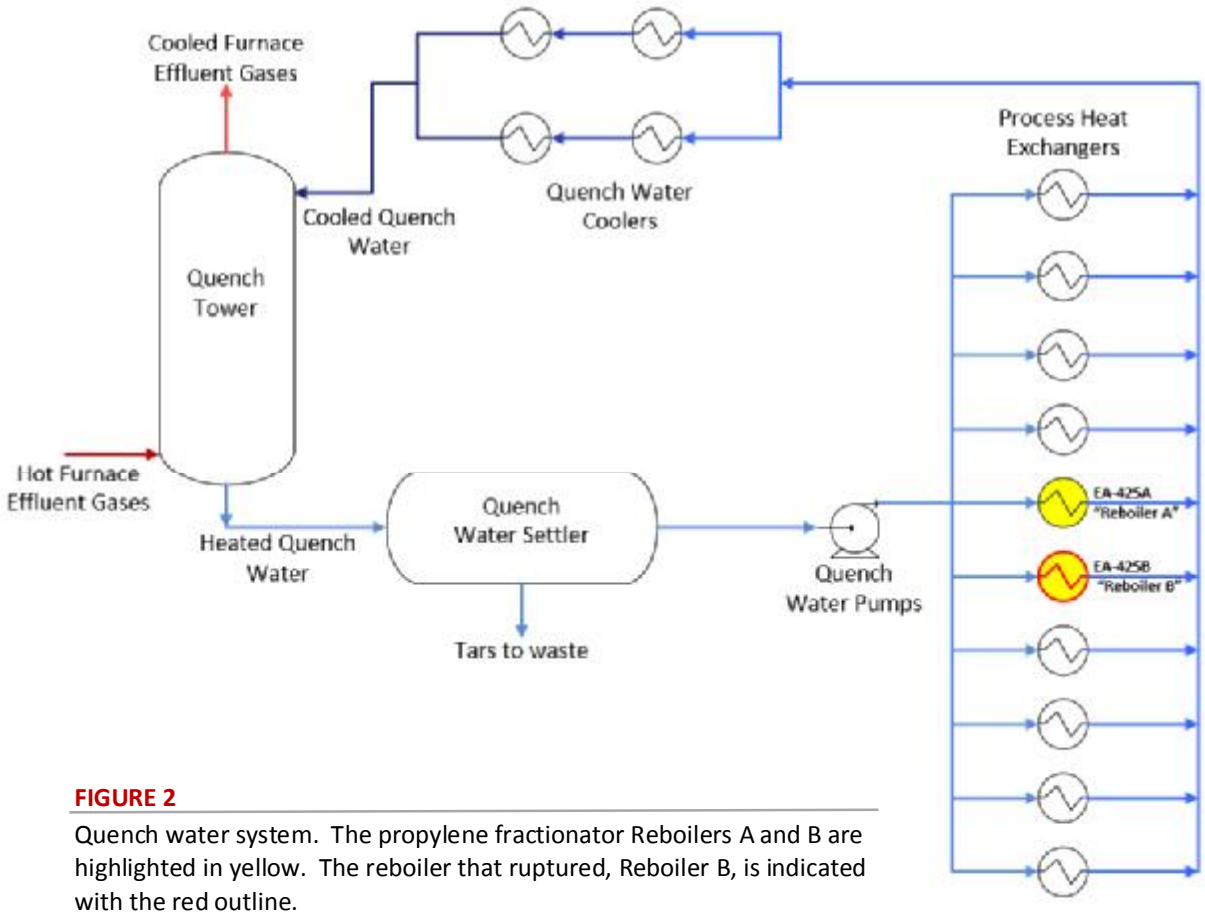
FIGURE 2

Quench water system. The propylene fractionator Reboilers A and B are highlighted in yellow. The reboiler that ruptured, Reboiler B, is indicated with the red outline.

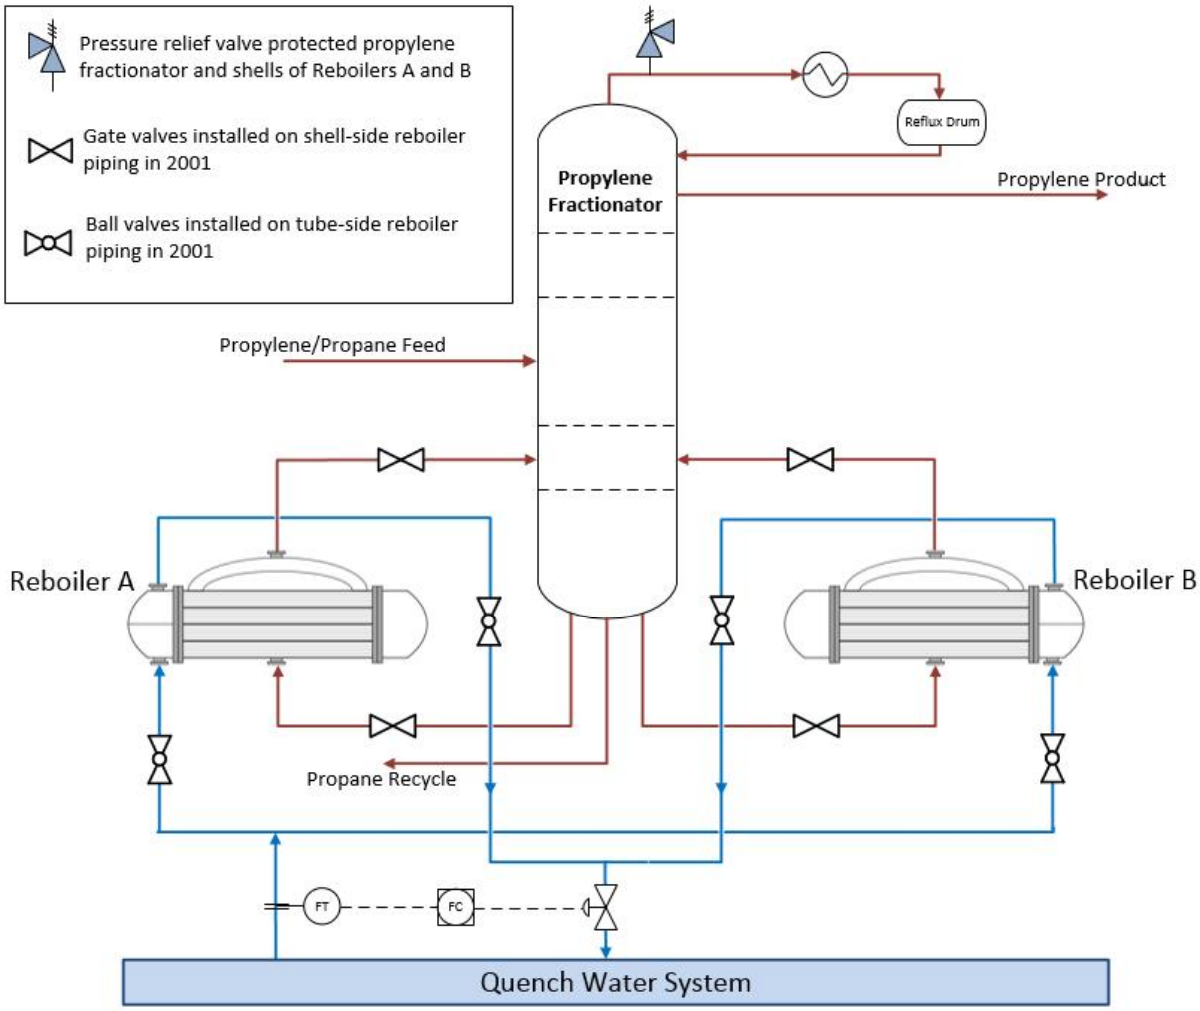
FIGURE 4

Propylene fractionator schematic. This schematic represents the equipment configuration at the time of the incident. The valves (gate valves) isolating the reboilers from the pressure relief valve at the top of the propylene fractionator were not part of the original design, and were installed in 2001. Section 5.1 provides additional information about these valves.

Post-incident field observations identified that the Reboiler B tube-side hot quench water valves were in the open position (Figure 10). The shell-side process valves were closed, which isolated the shell of Reboiler B from its protective pressure relief valve on the top of the propylene fractionator (Figure 4). This valve alignment shows that heat was introduced into a closed system (i.e., the blocked-in Reboiler B shell).

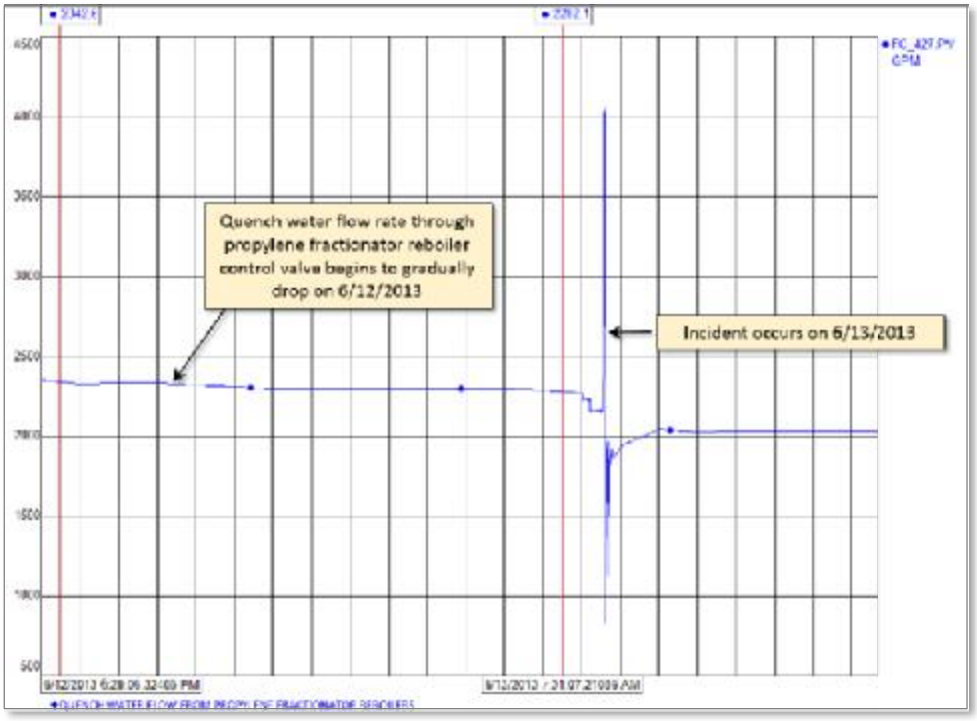
FIGURE 5

Graph of quench water flow rate through propylene fractionator Reboiler A prior to incident. Williams personnel identified that quench water flow rate had dropped.

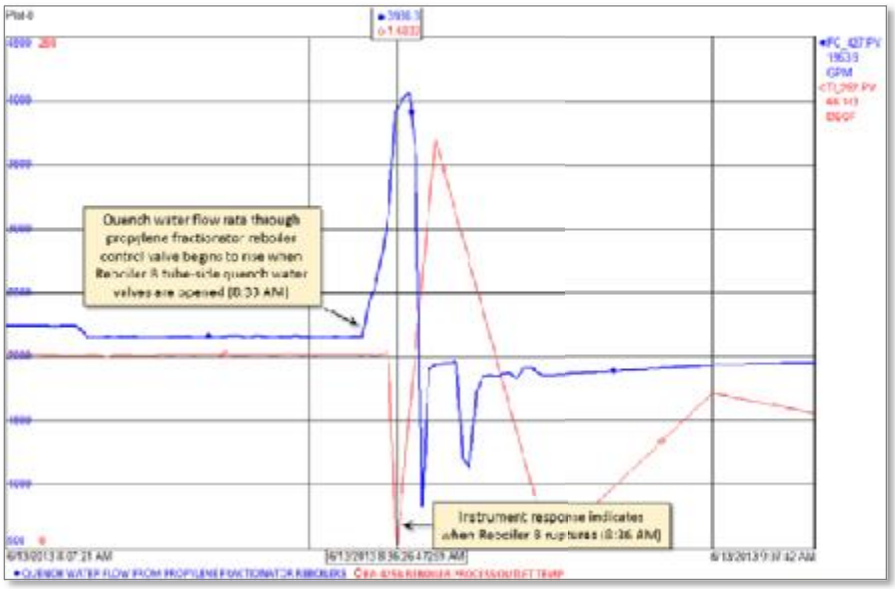
FIGURE 6

The CSB determined that at 8:33 am, the operations supervisor likely opened the quench water valves on the offline reboiler, Reboiler B, as indicated by the rapid increase in quench water flow rate shown in Figure 6. Approximately three minutes later, Reboiler B exploded (Figure 7). Propane and propylene process fluid erupted from the ruptured reboiler and from the propylene fractionator due to failed piping. The process vapor ignited, creating a massive fireball. The force of the explosion launched a portion of the propylene fractionator reboiler piping into a pipe rack approximately 30 feet overhead (Figure 8).

Graph of quench water flow rate immediately prior to incident. Quench water flow rate rises when Reboiler B tube-side quench water valves are opened. Reboiler B ruptures approximately three minutes later.

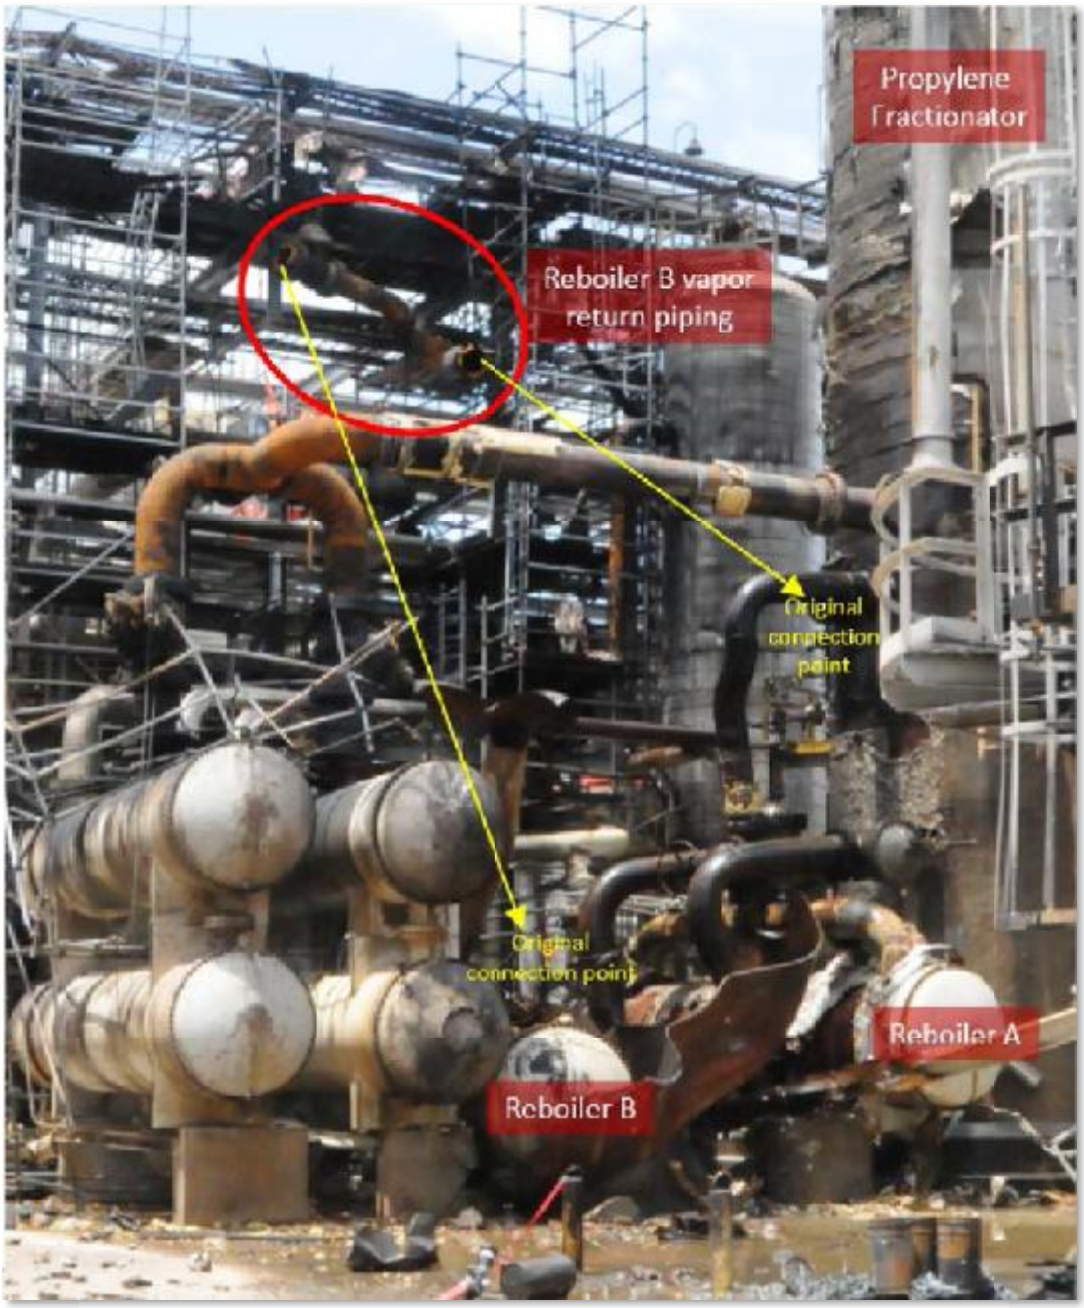
FIGURE 8

Post-incident photo of the propylene fractionator reboilers and surrounding area. The Reboiler B vapor return piping can be seen overhead in the pipe rack (red circle). The approximate original configuration of the piping and equipment is shown in Figure 9 and Figure 14.

The propane then found an ignition source and ignited, creating a massive fireball. The blast effects flattened the reboiler shell (Figure 12).

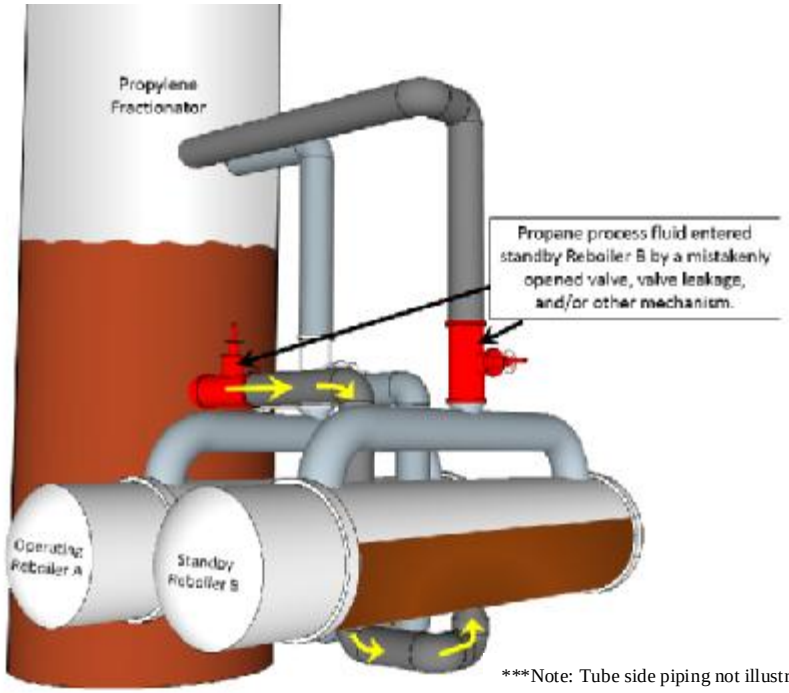
FIGURE 9

Closed gate (block) valves leak, and they are susceptible to inadvertent opening. Both scenarios can introduce process fluids to offline equipment. More robust isolation methods, such as inserting a blind, can better protect offline equipment from accumulation of process fluid.

Propane process fluid mixture entered standby Reboiler B by a mistakenly opened valve, valve leakage, and/or another mechanism.

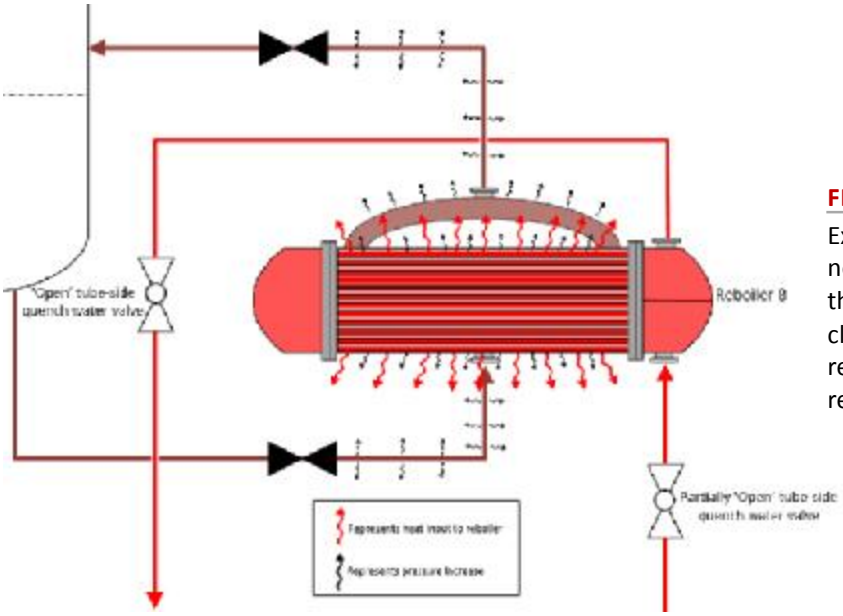
FIGURE 11

When the Reboiler B hot quench water valves were opened, the liquid propane within the standby Reboiler B shell began to heat up. This caused the liquid propane to increase in volume due to liquid thermal expansion,[23] filling any remaining occupiable vapor space within the shell. When the liquid could no longer expand due to confinement within the blocked-in Reboiler B shell, the pressure rapidly increased[24] until the internal pressure exceeded the shell's mechanical pressure limit (Figure 11), and the reboiler shell failed.[25]

Expanding shell-side liquid propane could not sufficiently increase in volume due to the lack of overpressure protection and the closed shell-side process valves. As a result, shell-side pressure increased until reboiler shell failed.

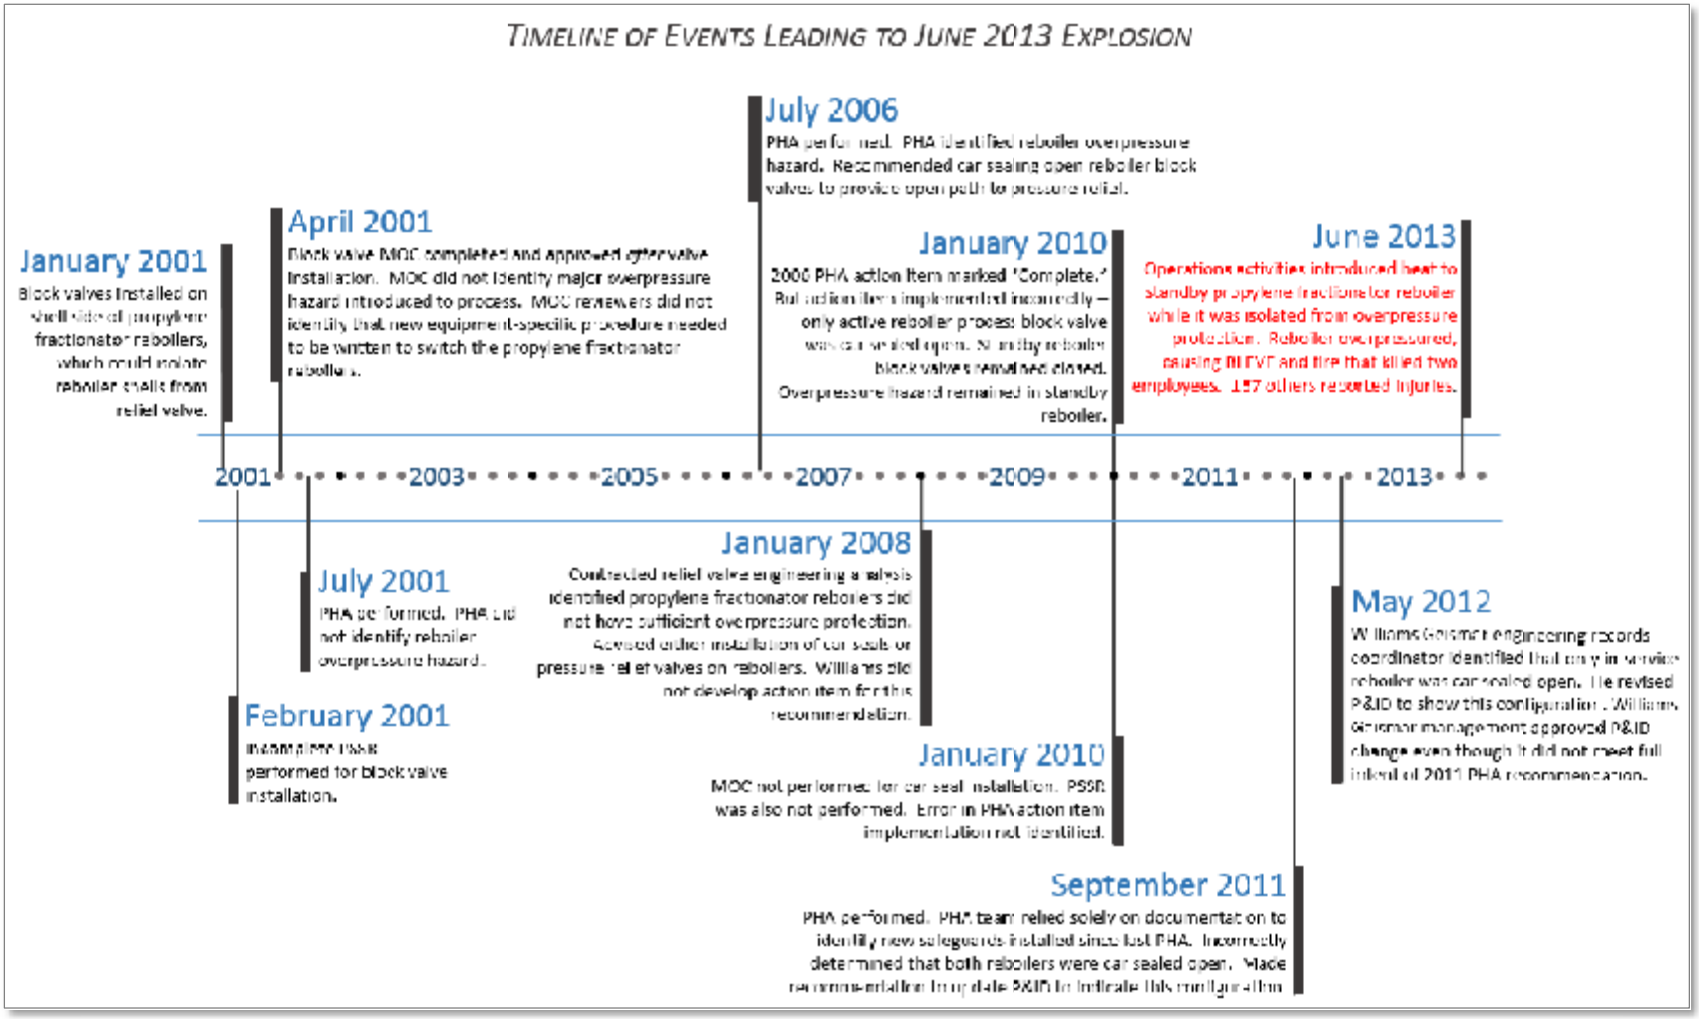
As will be explained in this section, the ineffective implementation of the Williams Geismar process safety management programs[28] (Figure 13 shows a timeline of the program deficiencies during the 12 years leading to the incident), as well as weaknesses in Williams' written programs themselves, were causal to the incident. Weaknesses in these programs resulted from a culture at the facility that did not foster and support strong process safety performance. Discussed in the following sections, Williams Geismar's process safety management program deficiencies that contributed to the incident include:

FIGURE 13
Timeline of events leading to the June 2013 incident.

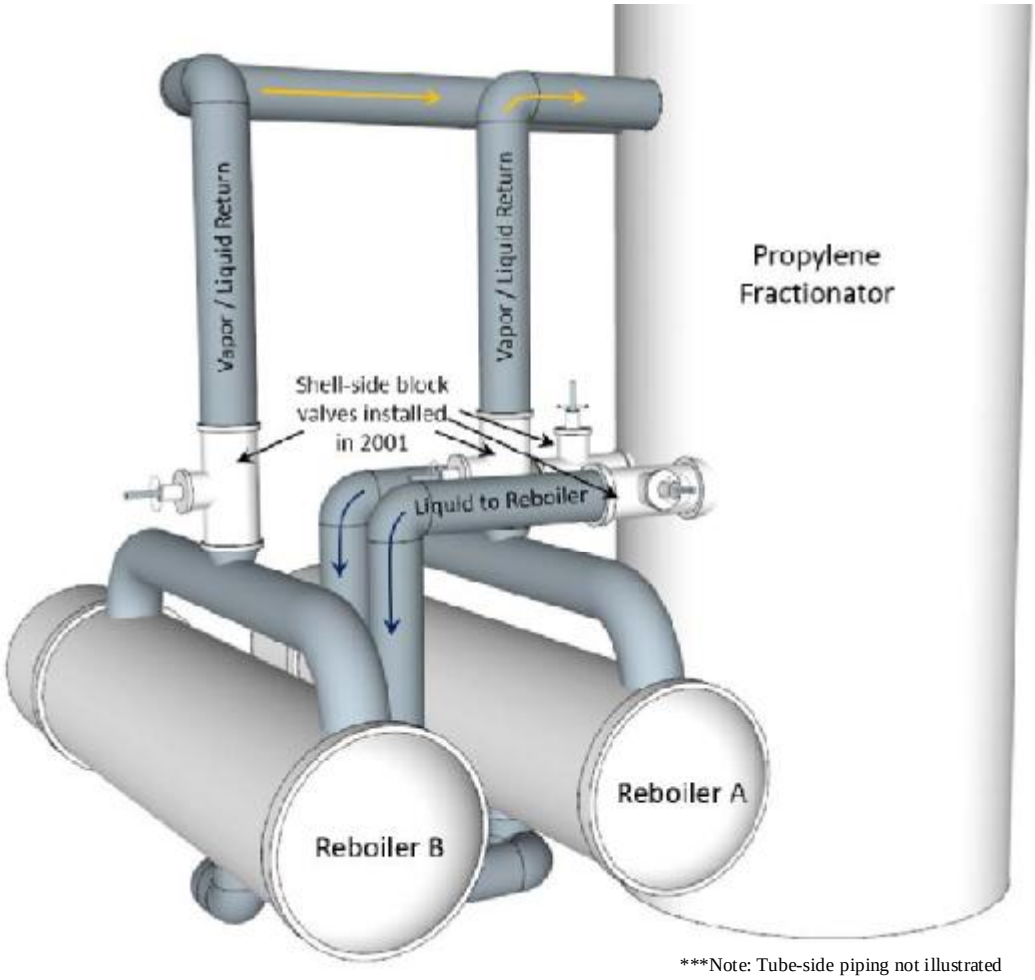
FIGURE 14

The original 1967 design of the propylene fractionator required both Reboiler A and Reboiler B in service at the same time. This design had no valves between the reboilers and the propylene fractionator, protecting the two reboilers from overpressure with the relief device located on top of the propylene fractionator. In subsequent years, Williams determined that the propylene fractionator could operate with only one reboiler in service. Operating with a single reboiler allowed continuous propylene fractionator operation and avoided shutdowns when the reboiler tubes fouled and required cleaning. To implement single reboiler operation, in 2000 Williams Geismar management approved a $270,000 investment to install valves on both the process side and quench water side of six of the quench water heat exchangers, including the propylene fractionator's Reboiler A and Reboiler B. In 2001, Williams installed the valves (Figure 14); however, Williams did not identify the overpressure hazard that resulted from this change.

Illustration of the propylene fractionator reboilers prior to the incident, with shell-side piping shown. The four shell-side process valves were installed in 2001.

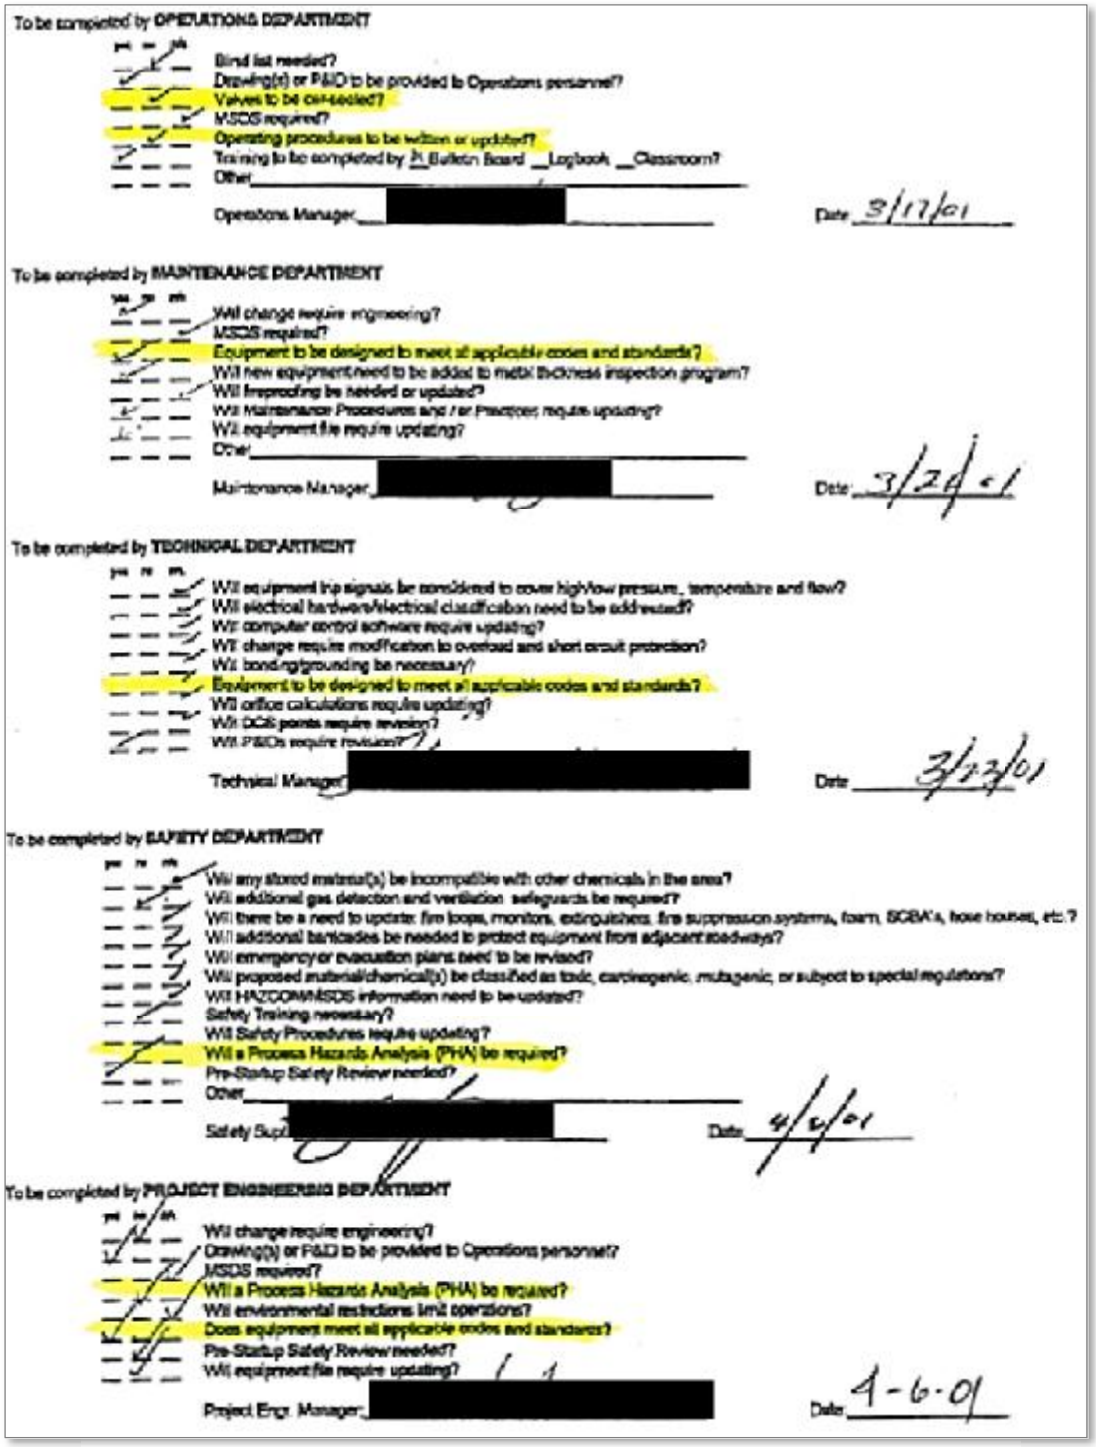
FIGURE 15

Installing block valves into a process where they previously did not exist is a significant process change that needs careful safety analysis during the MOC review. But the Williams 2001 MOC review did not identify the significant overpressure hazard introduced by the valves. Figure 15 highlights portions of the Williams MOC that the CSB identified as ineffective assessment of the change presented by the new valves. These weaknesses include:

Portion of the MOC performed by Williams for the installation of the valves on Reboilers A and B. Yellow highlights indicate weaknesses in MOC analysis. Note: Image of document is poor quality.

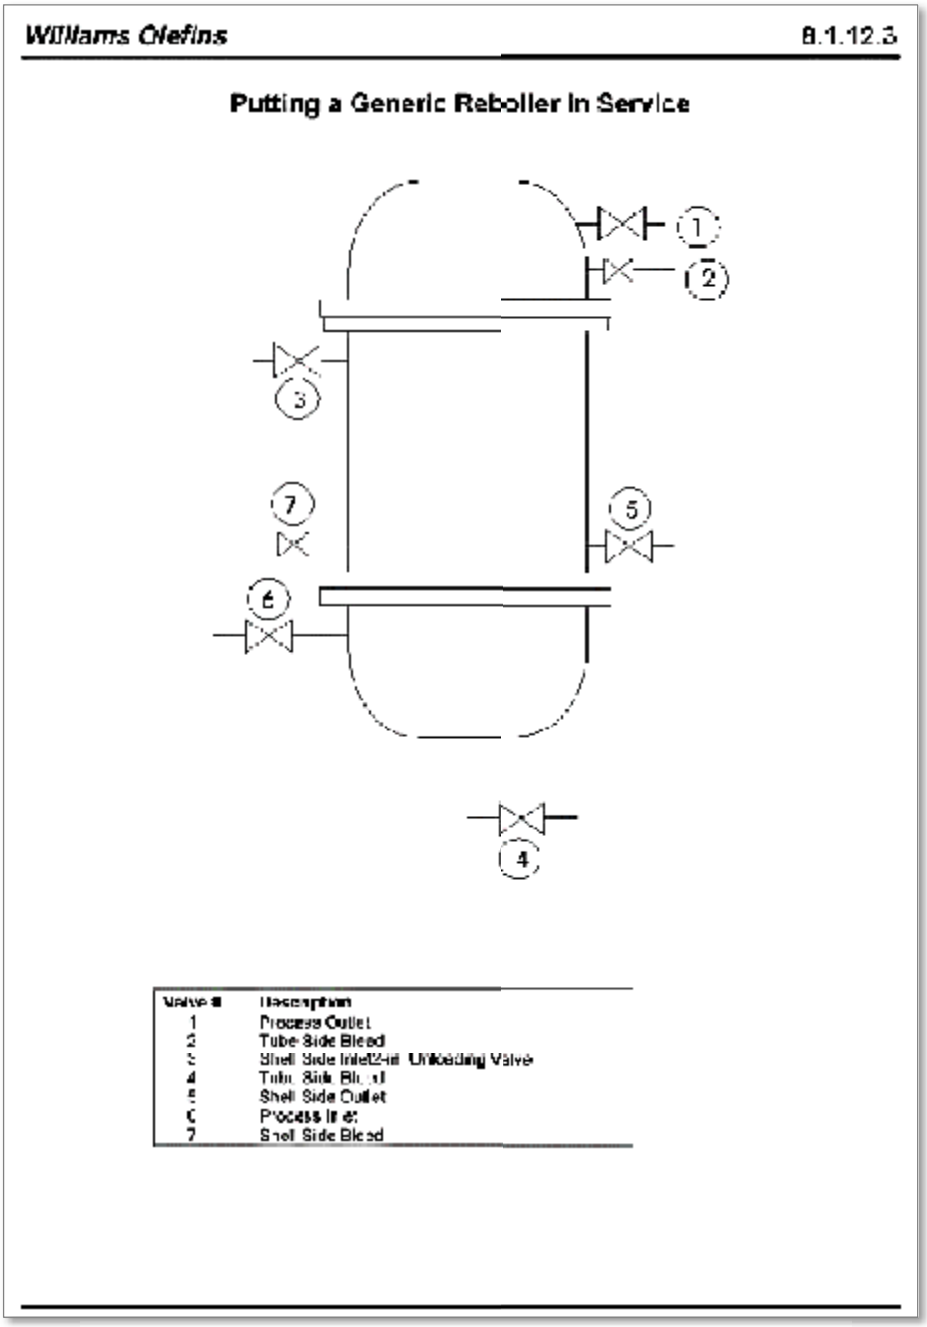
FIGURE 16

Schematic from the Williams Geismar Generic Reboiler Startup Procedure. This was the applicable procedure to startup the propylene fractionator reboilers. Since the procedure uses the reverse of the Reboiler B configuration, it can be confusing, and workers could initiate a high-pressure scenario on the shell (process) side. Williams had not equipped this reboiler with a protective pressure relief device.

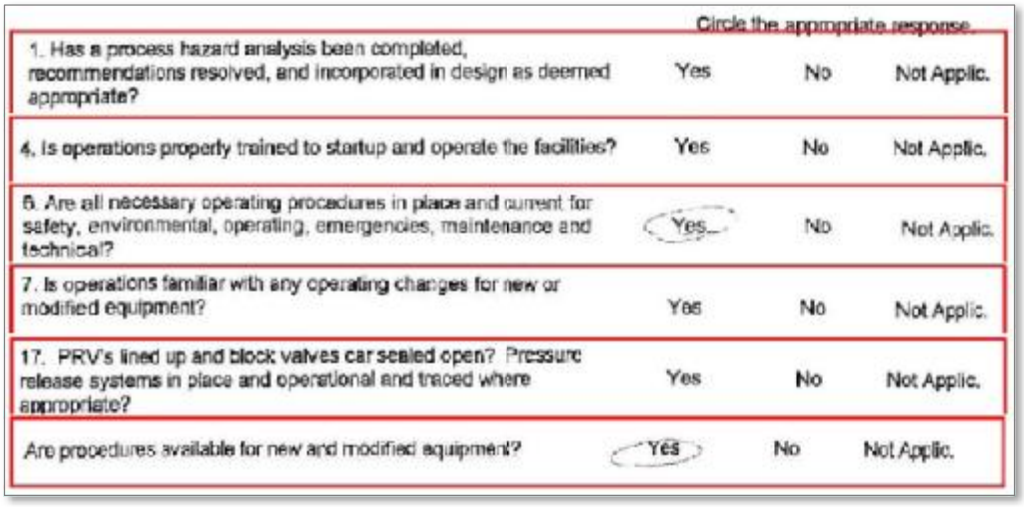
FIGURE 17

When a company does not effectively implement its written safety management programs—such as only partially completing the PSSR document and incorrectly answering some of the document questions—it indicates a weakness in process safety culture (see Section 9.0). Management's approval of incomplete documentation can lead to a culture of complacency and, therefore, subpar and incomplete process safety analyses. At a company with a strong commitment to effectively implementing process safety management programs, everyone—from the front line worker to company executives—should perceive incomplete documentation, such as this PSSR document, as unacceptable.

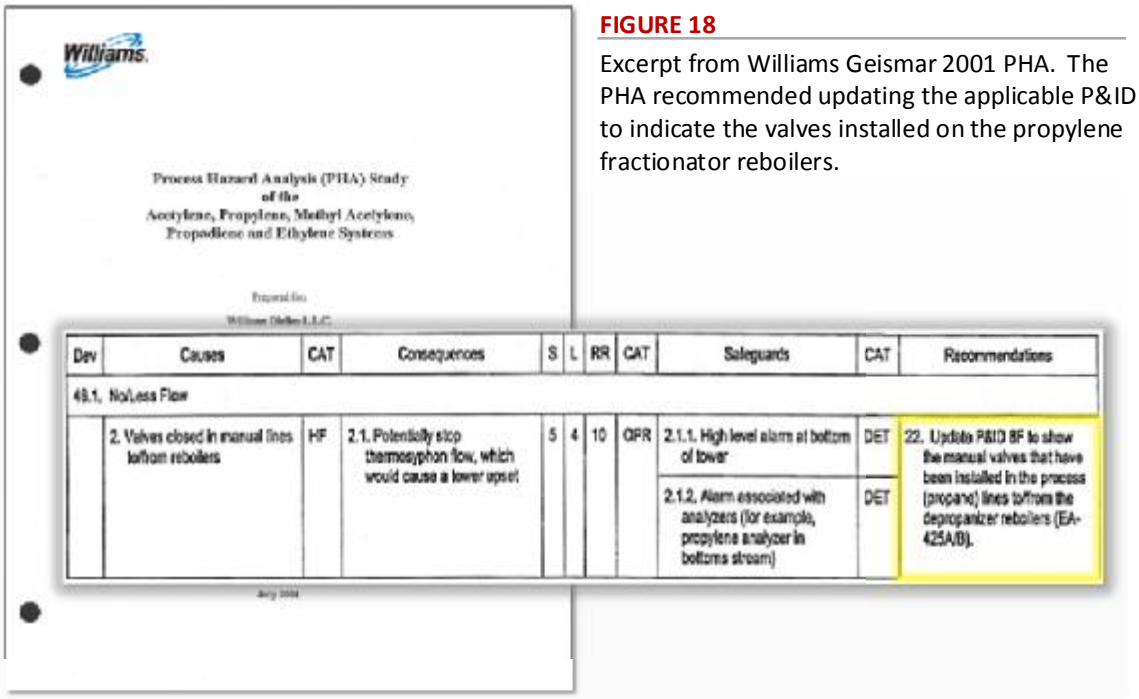
FIGURE 18

The PHA team correctly identified that the piping and instrumentation diagrams (P&IDs) did not show the new valves on the propylene fractionator reboilers. The PHA team recommended updating the relevant P&ID (Figure 18). The CSB notes that the P&ID update should have been required as part of the MOC process. In addition, the PSSR process should have reviewed a marked-up version of the P&ID showing the approved change. Such a review could have identified the significant error with the engineering drawing.

Excerpt from Williams Geismar 2001 PHA. The PHA recommended updating the applicable P&ID to indicate the valves installed on the propylene fractionator reboilers.

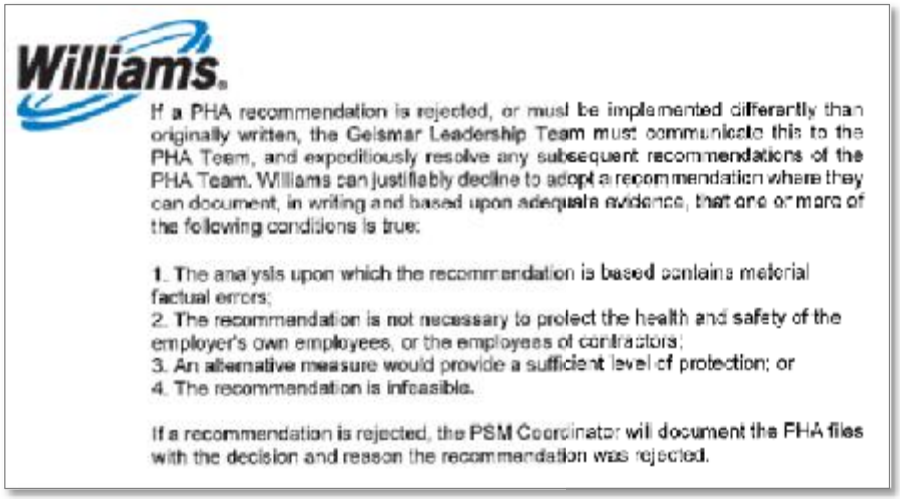
FIGURE 25

Before the incident, the Williams Geismar PHA procedure did not specify a method to follow when the leadership team decided to reject a PHA recommendation or deviate from the proposed recommendation language. Identifying this gap after the incident, Williams Geismar updated the Geismar PHA procedure accordingly (Figure 25), requiring a more robust process when deviating from the proposed PHA recommendation.

The Williams Geismar revised, post-incident PHA procedure now specifies a method the leadership team must follow to implement PHA recommendations differently than originally worded.

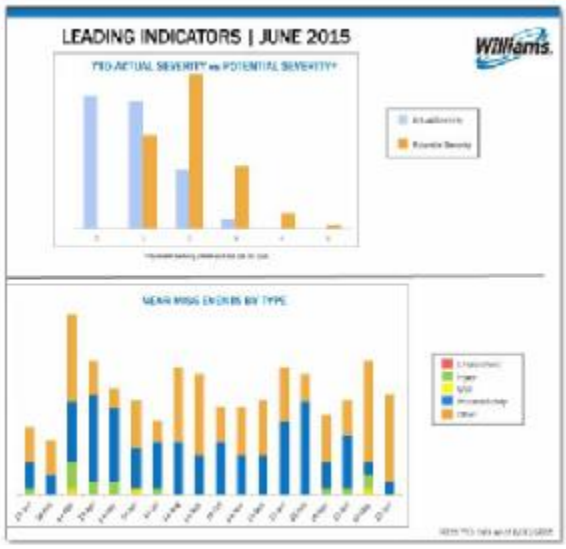
FIGURE 26

Williams Geismar did not effectively measure leading and lagging process safety indicators before the incident. Such a system could have identified the excessive time it was taking to implement PHA action items. For example, it took three and a half years to close the 2006 PHA action item to car seal open the propylene fractionator reboiler valves. Since the incident, Williams worked to develop a leading and lagging process safety metrics system. For example, Williams Geismar increased its focus on incident and near miss[74] reporting, and these events are now valued as learning opportunities. Williams distributes incident and near miss reports to all facility leads, supervisors, engineers, and managers. In addition, the company now investigates high potential near miss incidents using a root cause methodology. Williams began performing statistical analyses on the incidents reported, and the trends and findings are distributed each month to Williams employees and senior managers (Figure 26). Williams also implemented electronic tools and databases to track PHA action items and preventive maintenance items—with the ability to report overdue items or upcoming due dates for action items to management.

Sample indicators report circulated to Williams Geismar management.

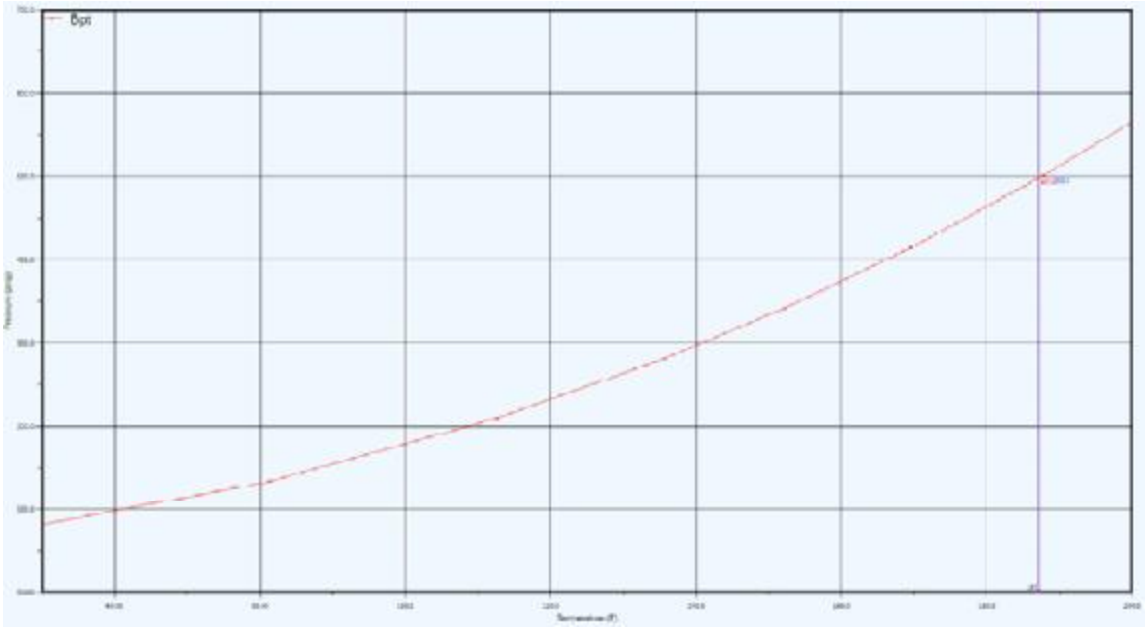
FIGURE B-1

Boiling Point Curve of Williams reboiler process fluid. Graph indicates process fluid could generate a vapor pressure of 496 psig at equilibrium conditions.

The tube-side quench water was at a temperature of 187 °F. At equilibrium conditions at 187 °F, the shell-side propane mixture generates a vapor pressure of approximately 496 psig (Figure B-1). This pressure is not high enough to have ruptured the reboiler, which Finite Element Analysis predicts ruptured between 674 and 1,212 psig.[86] The CSB concludes that the overpressurization of the Williams reboiler was likely not caused by an increase in vapor-liquid equilibrium pressure when heat was introduced to the closed shell side of the reboiler.

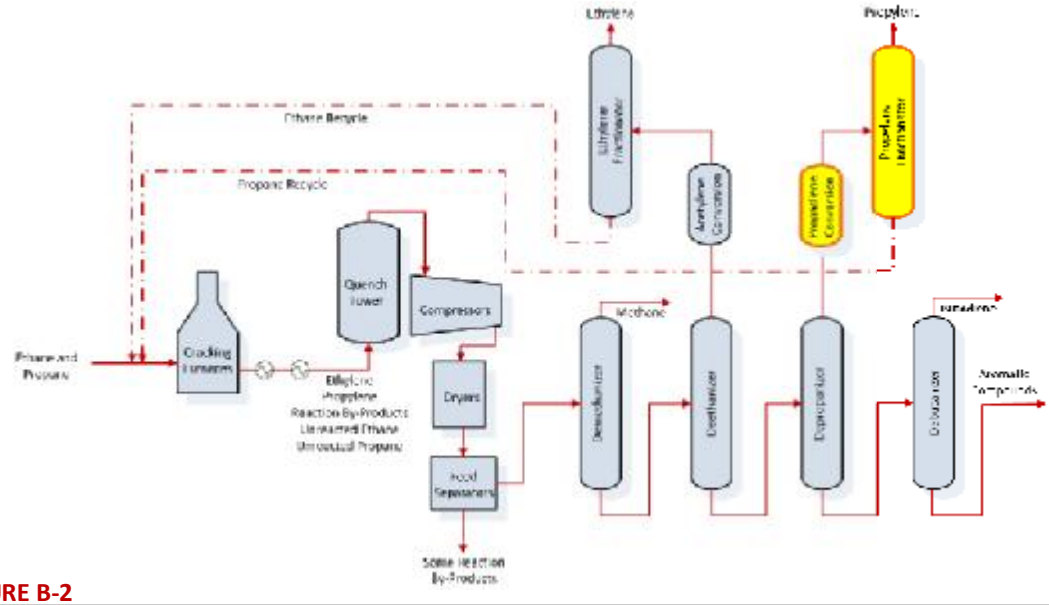
FIGURE B-2

The CSB analyzed whether the decomposition and ignition of MAPD in the reboiler shell caused this incident. Williams regularly sampled the MAPD composition exiting the propadiene converter, which was immediately upstream of the propylene fractionator (Figure B-2). The propadiene converter was installed into the process specifically to prevent accumulation of MAPD in the process. Plant data indicates the propadiene converter was functioning normally between a February 2012 maintenance activity and the day of the incident. Between the time Reboiler B was last opened for maintenance (February 2012) and the incident, available composition data indicates that the process fluid entering the propylene fractionator did not exceed approximately 1.4 mol% MAPD. This concentration likely was not enough to accumulate a high percentage of MAPD in the standby reboiler, which was isolated from the propylene fractionator by closed valves.

In a 2013 presentation by Dow at the AIChE Ethylene Producers' Conference, two scenarios were identified that could result in accumulation of MAPD in a propylene fractionator: operating on total reflux or operating with a loss of bottoms flow.[89] The propylene fractionator was not operated under either condition between February 2012 and the incident. The CSB concludes that this incident was likely not caused by the accumulation and detonation of MAPD in the offline Reboiler B.

Simplified flow diagram of the olefins process. The propadiene converter and the propylene fractionator are highlighted in yellow.

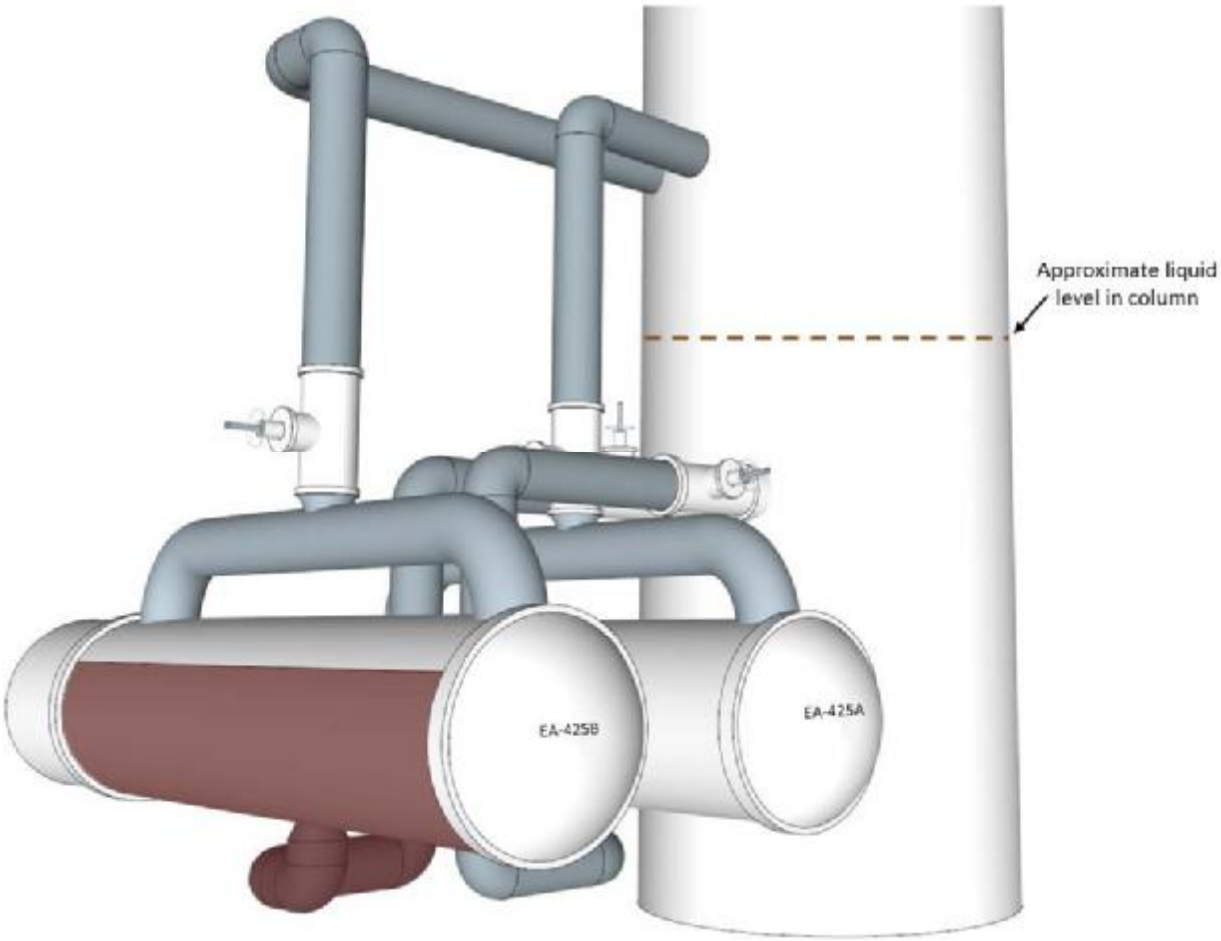
FIGURE B-3

The piping and exchanger shell between the two closed reboiler process valves had to be *at least* 65.5 vol% full of the liquid propane mixture prior to the introduction of hot quench water to the tube side of the reboiler for liquid expansion to result in overpressurization of the exchanger shell and piping. A liquid inventory of at least this

minimum quantity of liquid is reasonable because (1) it would have resulted in a level in the reboiler below the liquid level in the propylene fractionator, and (2) this quantity of liquid would have had enough contact with the reboiler tubes to sufficiently heat and expand (Figure B-3). Reboiler B was likely between 65.5 vol% and 100 vol% full of the liquid propane mixture prior to the introduction of the 187 °F quench water.

Depiction of minimum required liquid level in reboiler EA-425B (Reboiler B) to result in possible liquid overpressurization of reboiler shell.
