U. S. CHEMICAL SAFETY AND HAZARD INVESTIGATION BOARD

INVESTIGATION REPORT

PROPANE TANK EXPLOSION (2 DEATHS, 7 INJURIES)

Herrig Brothers Feather Creek Farm
Albert City, Iowa
APRIL 9, 1998

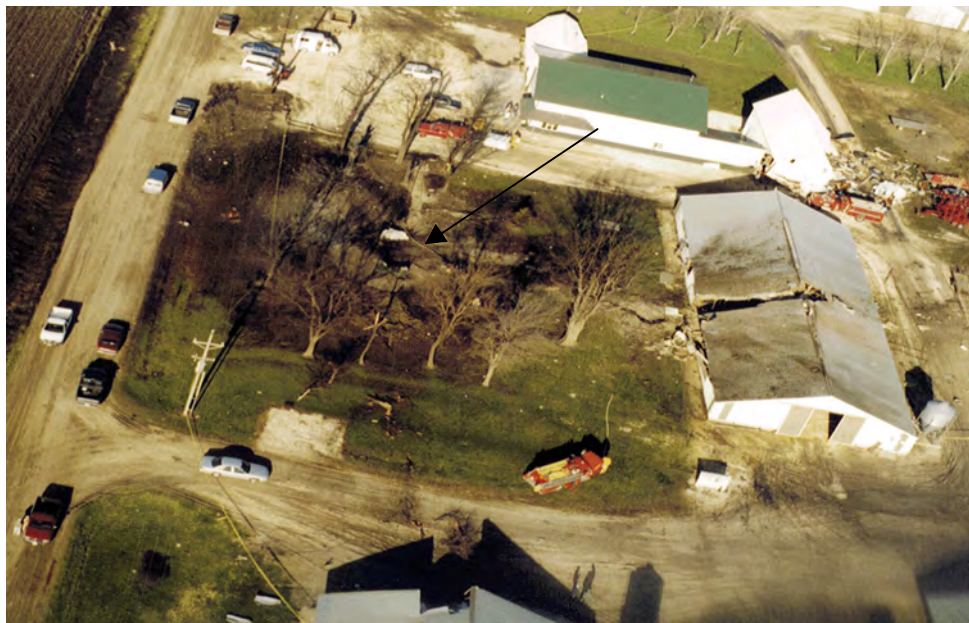
Figure 1. Aerial View of the Farm on April 10, 1998

On April 9, 1998, at approximately 11:28 pm, an 18,000-gallon propane tank exploded at the Herrig Brothers Feather Creek Farm (the farm) in Albert City, Iowa. The blast occurred less than half an hour after an all-terrain vehicle (ATV), driven by a minor without the owner's permission, damaged two aboveground propane pipes and a fire resulting from that accident engulfed the tank. The explosion that occurred at the farm is known as a Boiling Liquid Expanding Vapor Explosion or BLEVE.¹ Tank fragments produced by the BLEVE killed two volunteer fire fighters.² In addition, seven other emergency response personnel were injured, and several buildings were damaged by the blast. The arrow in Figure 1 points to the location of the tank prior to the blast.

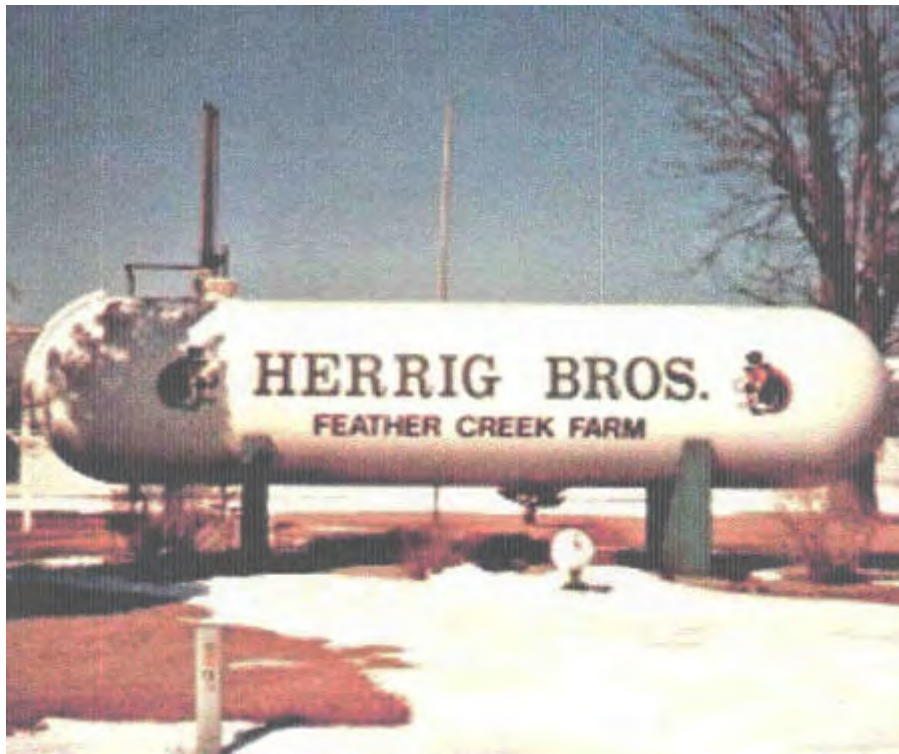
Figure 3. The 18,000-gallon Propane Tank That Exploded

The propane tank, which was made of carbon steel, was approximately 42 feet long and 9 feet in diameter. It was located approximately 78 feet north of the 490th Street centerline (see Figure 2, item 6). The tank rested on two concrete saddles with the bottom of the tank located approximately 4 feet above ground level. Figure 3 is a view of the tank looking north from 490th Street.

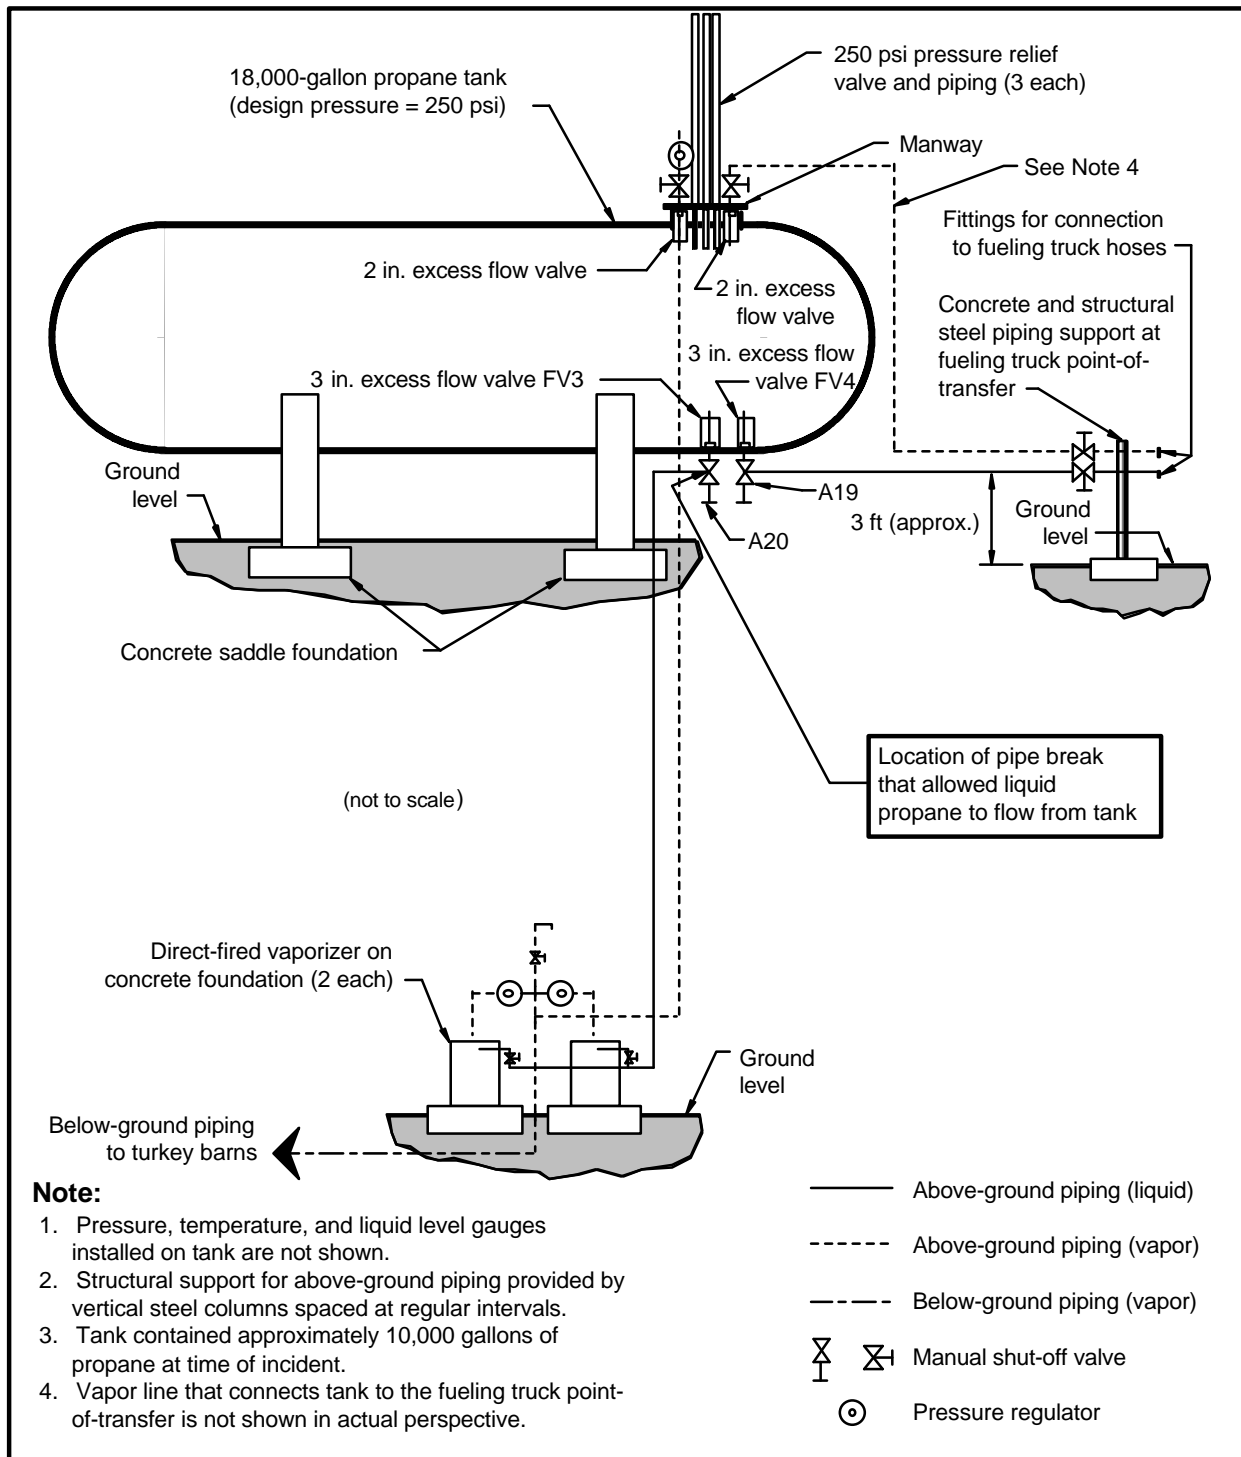
Figure 6. Piping Diagram for the Propane Storage and Handling System

During normal operations, liquid propane was withdrawn from the tank through the 3-inch excess flow valve (FV3 in Figure 6), past the open shut-off valve (A20 in Figure 6), and then into the ¾-inch outlet pipe to the vaporizers shown in Figure 7. These vaporizers used heat to convert the liquid propane into a gas. After passing through a pressure regulator, the propane gas was piped underground to the various space heaters and furnaces located in the buildings on the farm.

At this installation, however, the piping downstream of the excess flow valve did not conform to this NFPA requirement. Specifically, shut-off valve A20, which was downstream from excess flow valve FV3, was fitted with two bushings that reduced the flow of propane by decreasing the diameter of piping in the line to approximately $\frac{3}{4}$ of an inch. In this incident, the break in the line occurred at the point where the second bushing connected to the $\frac{3}{4}$ -inch outlet pipe to the vaporizers (see Figure 6). Following the break, the excess flow valve did not close because the flow of propane through the line was restricted by the reducer bushings to a rate below the closing rating of the valve.

Shut-off valves A19 and A20, used on the liquid propane piping lines (see Figure 6), were rated for 400-psi service at temperatures up to 150°F. However, pressure required to cause failure is usually at least twice the rated operating pressure. Shut-off valves A19 and A20 did not fail by overpressurization. Observed damage was probably caused by impact following the explosion.

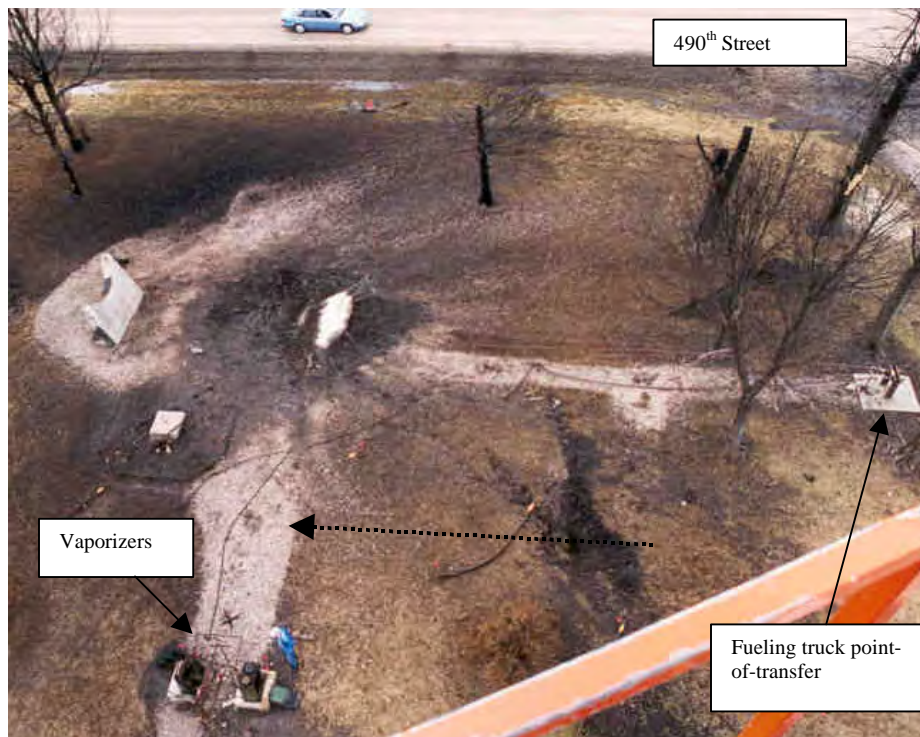
Figure 7. Aerial View of Tank Area

- 1) Parallel liquid and vapor lines used for propane supply ran to the west for approximately 40 feet. These lines terminated at the fueling truck point-of-transfer located at the edge of a gravel parking area (see Figure 2, item 8 and Figure 7). These lines were not involved in this incident.
- 2) Parallel liquid and vapor lines also ran north from the tank for approximately 37 feet to two direct-fired vaporizers⁶ (vaporizers) (see Figure 2, item 7 and Figure 7). The liquid line was located to the east of the vapor line. The ATV struck these two lines.

On cold winter days, as much as 1,000 gallons of propane were required to heat the buildings and structures on the farm. Based on this usage, fueling truck deliveries occurred as often as every week during severe winter months. When a fueling truck arrived at the farm, it parked in the gravel area located west of the propane tank (see Figure 2, item 8). The dotted arrow in Figure 7 below represents the approximate course of the ATV prior to striking the propane lines.

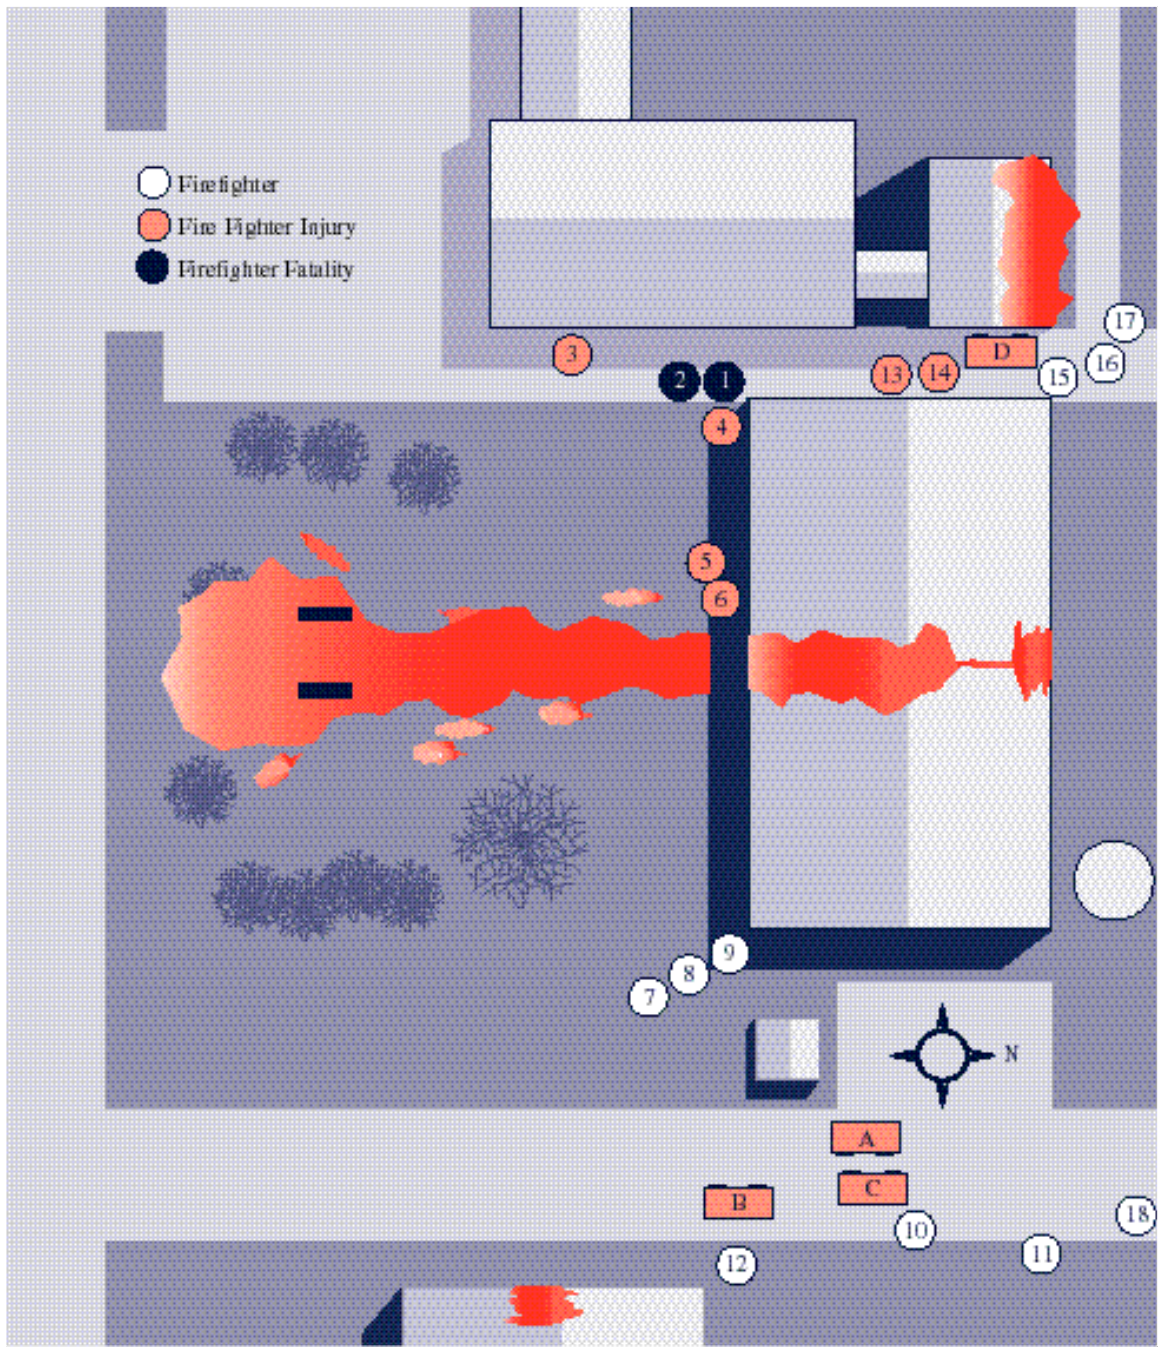
Figure 8. Fire fighters (numbers) and Response Vehicles (letters) at the Time of the Blast (not to scale)

killing two volunteer firemen. The Iowa State Medical Examiner listed the cause of death in each instance as massive trauma to all body systems. The fire fighters who died were located about 100 feet from the northwest side of the tank, as depicted in Figure 8 (numbers 1 and 2). The tank piece that struck two of the fire fighters narrowly missed the Fire Chief (see Figure 8, number 4). Another large piece of the tank was propelled directly north, just missing two other fire fighters (see Figure 8, numbers 5 and 6). Seven emergency response personnel sustained injuries as a result of the explosion. These injuries ranged from scrapes and bruises to severe burns.¹⁵ This explosion easily could have caused numerous additional fire fighter fatalities.

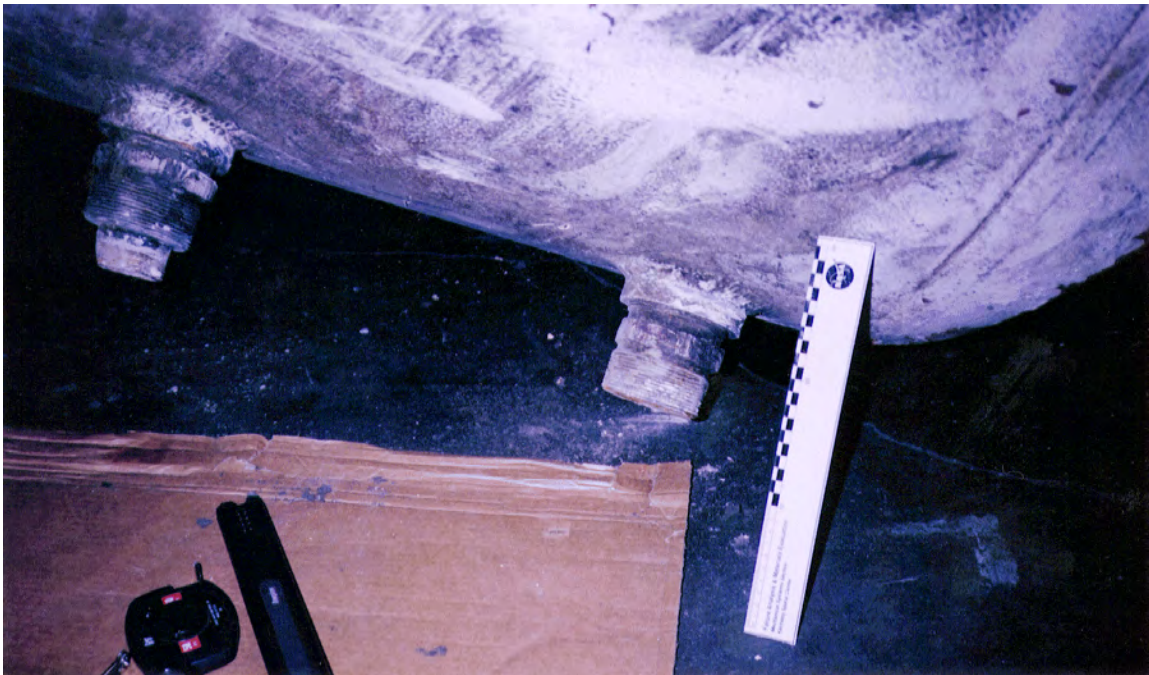
FIGURE 1

- 2.4 Two liquid excess flow control valves from the base of the ruptured propane tank were sent to KSC for testing and examination. The two valves are shown installed in the tank section in Figures 1 and 2. Figure 3 shows the excess flow control valve designated FV4 (that previously connected to the liquid tank fill stub) after the valve had been removed from the tank section. Valve FV4 is shown as-received in the laboratory in Figure 4. Figure 5 shows the second excess flow control valve, FV3, as-received in the laboratory. Valve FV3 fed the pipeline connected to the vaporizer system.

The two liquid excess flow control valves in the tank section prior to removal for testing purposes.

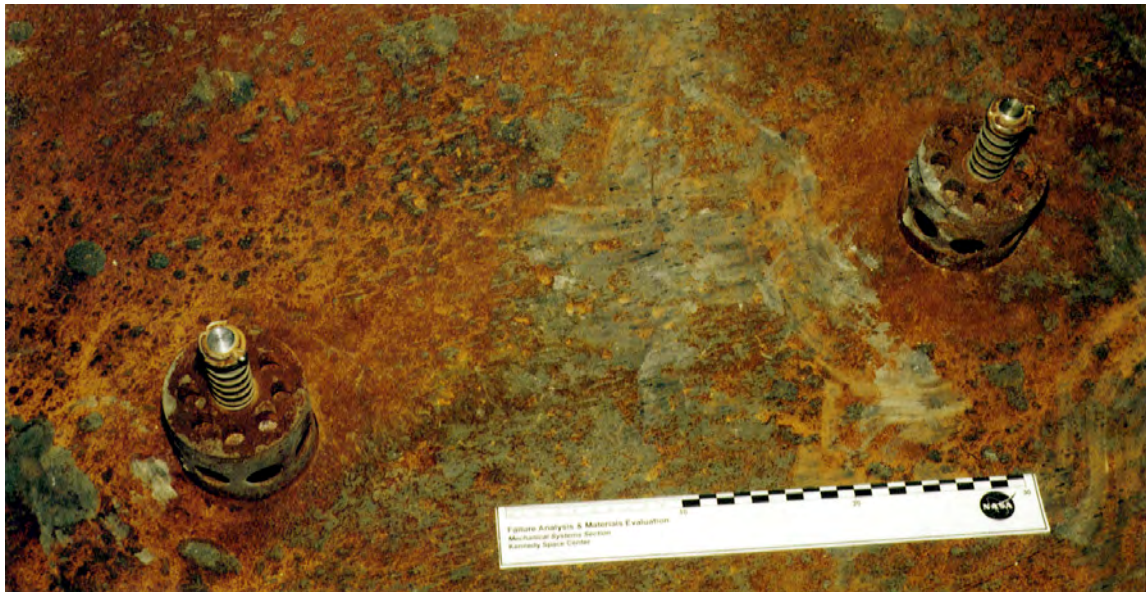
FIGURE 2

The two liquid excess flow control valves as seen from the interior side of the tank section.

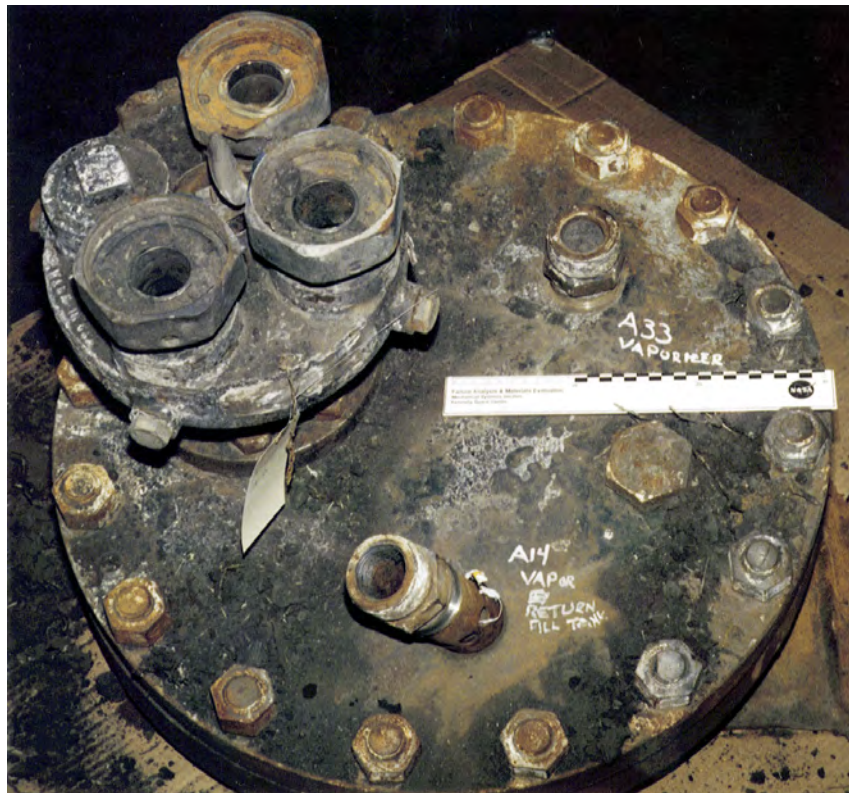
FIGURE 6

- 2.5 The man-way cover containing the two smaller excess control valves is shown in Figure 6. These two excess control valves were used in the vapor side of the propane system. Valve A14, used in the vapor return line for the tank filling system, is shown in Figure 7 as it was received in the laboratory. The excess flow control valve that connected to the vaporizer system, A33, is shown in Figure 8 as it was received in the laboratory. It can be noted in Figure 6 that the three pressure relief valves on the small castle on the man-way have disintegrated and the internal parts have blown out.

Propane tank man-way cover as seen in the Des Moines, Iowa storage warehouse. Vapor excess flow control valves are labeled A14 and A33. Three pressure relief body shells can be seen on the elevated connection plate.
