U.S. CHEMICAL SAFETY AND HAZARD INVESTIGATION BOARD

INVESTIGATION REPORT

TOXIC CHEMICAL VAPOR CLOUD RELEASE

MFG CHEMICAL, INC.

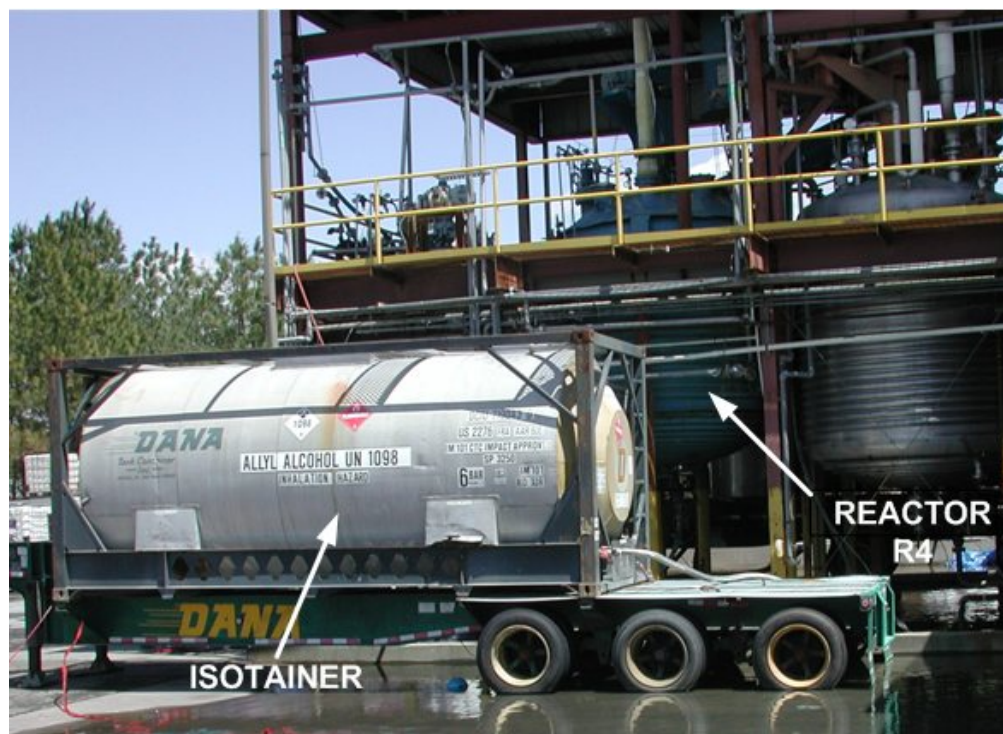
Lyondell maintains a product stewardship program⁵ for all hazardous chemicals that they manufacture. Three months before delivering the allyl alcohol, Lyondell personnel visited the MFG facility and conducted an assessment to evaluate the preparedness of MFG to handle a large quantity of allyl alcohol safely. Lyondell concluded that MFG could safely handle production quantities of allyl alcohol after they made improvements in fire suppression equipment, and provided additional personal protective equipment and training to employees who would be working with the chemical. On April 4, 2004, GPC issued a purchase order to Lyondell to supply 35,000 pounds (4940 gallons) of allyl alcohol to MFG. An isotainer of allyl alcohol arrived on April 12, 2004, a few hours before the incident occurred, and was parked adjacent to the reactor (Figure 2).

Figure 2. Isotainer (tanker) used to ship 35,000 lbs of allyl alcohol (looking east).

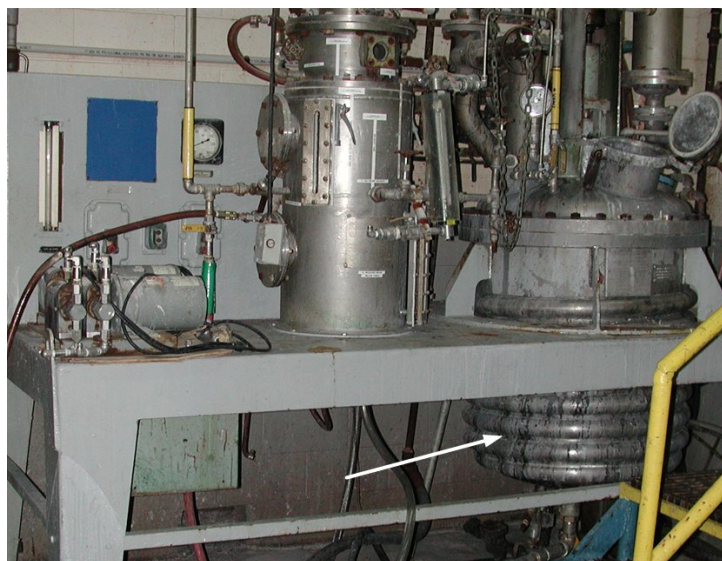
Controlling the temperature of the reacting chemicals was significantly more difficult in the 4000-gallon reactor than in the 30-gallon reactor. The heat removal capacity of a reactor equipped with an external jacket is directly proportional to the ratio of the jacketed surface area to the reactor volume. This surface-to-volume ratio decreases as the reactor volume increases,¹⁰ thus the ability to remove excess heat may be significantly less in a large production reactor compared to the bench-scale reactor. Scaling to the 4000-gallon production reactor made controlling the batch temperature much more difficult.

Figure 3. Small batch test reactors. Reactor cooling jacket (arrow) is similar to the 4000-gallon production reactor.

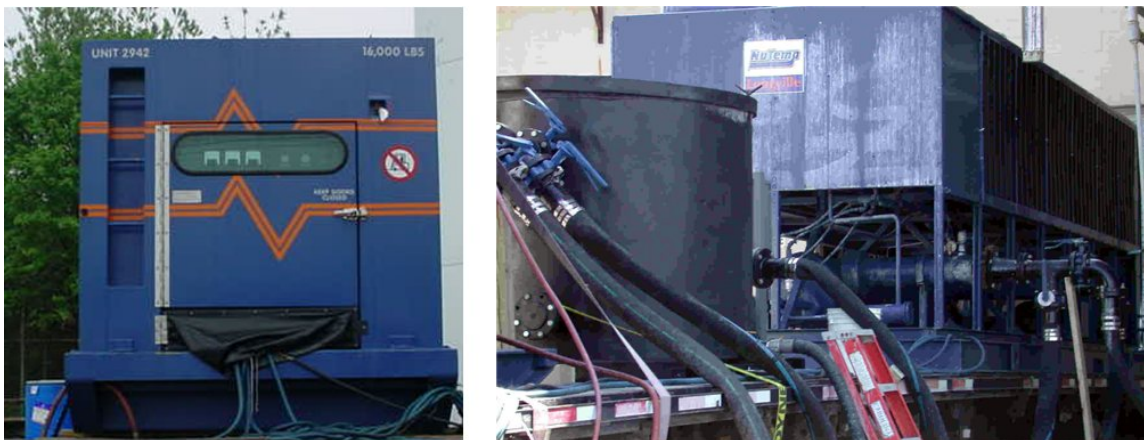
The chiller system arrived late in the morning of Monday, April 12, 2004 (Figure 4). The vendor technician made the necessary piping connections to the reactor cooling-jacket, started the system, and verified that it was operating properly. He then instructed the MFG personnel how to

start and stop the system. Since the TAC procedure did not specify any cooling system adjustments, the chiller system was not set up to provide for easy adjustments.

Figure 4. Portable cooling system used to cool the reactor. Generator (left), and chiller (right).

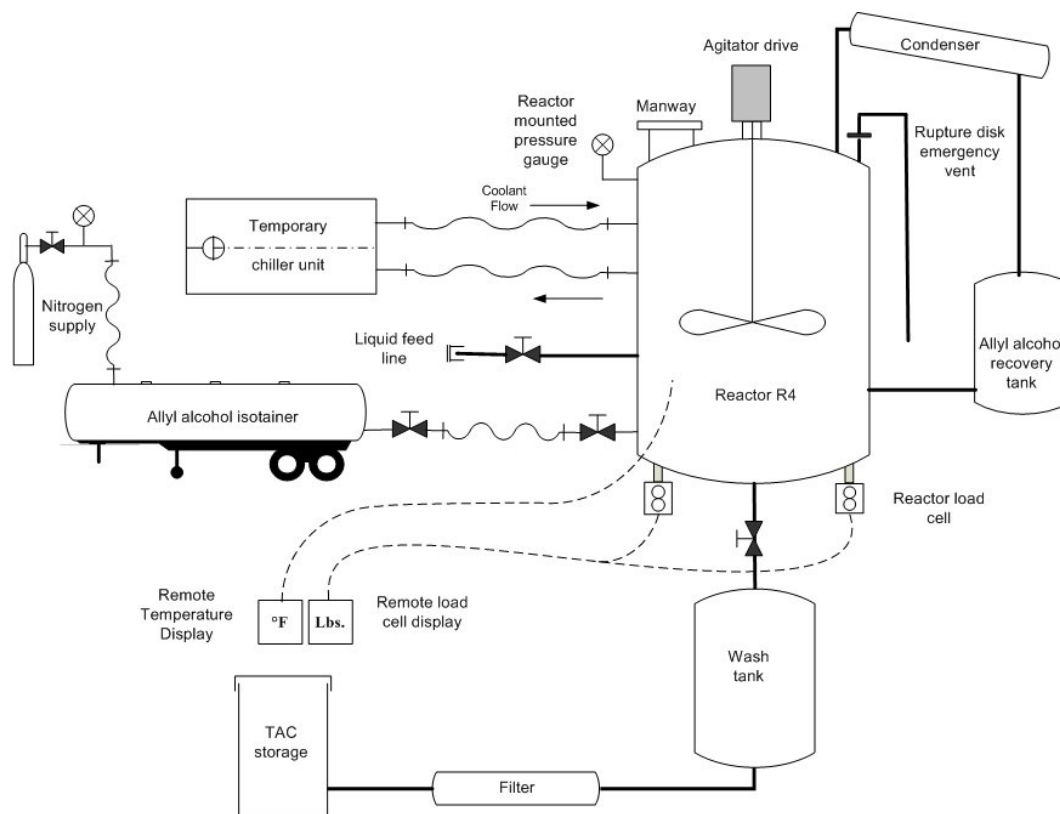
The operators loaded the dry-powder cyanuric chloride into the reactor on Friday, April 9, 2004 three days before the allyl alcohol and the temporary reactor cooling system arrived. They wore the personal protective equipment recommended on the MSDS. The reactor load cells on the reactor (Figure 5) measured the weight of the chemical specified in the procedure. The operators closed the reactor manway and installed some of the hold-down clamp bolts (Figure 6), after which a nitrogen gas blanket was established. The dry-powder chemical remained in the reactor throughout the weekend.

Figure 5. Basic TAC process diagram.

After a few minutes of transferring allyl alcohol into the reactor through the transfer piping, they concluded that it was going to require many hours to complete the transfer at the established flow rate. Because the procedure did not restrict the allyl alcohol fill-rate, the operators increased the nitrogen pressure to speed the transfer. At the higher flow rate, they completed the transfer in less than an hour. The operators closed both transfer-hose isolation valves, but left the hose attached to the equipment. The reactor agitator had been started sometime during the transfer operation to mix the chemicals (See Figure 5).

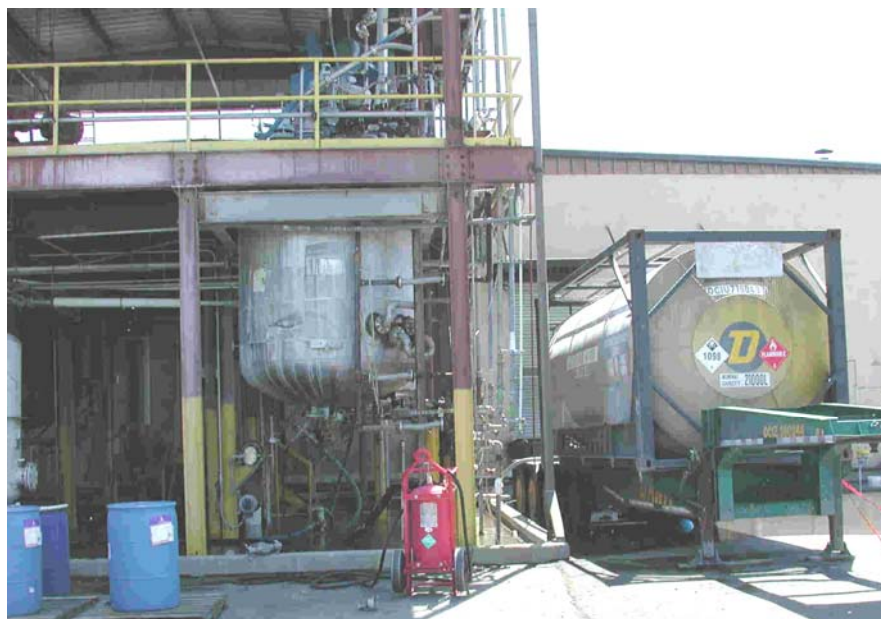
The allyl alcohol isotainer arrived in the afternoon on Monday, April 12 and was parked adjacent to the reactor (Figure 7). The engineering and compliance manager met with the operators and discussed the precautions and personnel protective equipment required for the allyl alcohol transfer into the reactor. They then connected the transfer hose to the process piping. The operators concluded the chiller was providing sufficient cooling to the reactor because the reactor interior temperature reading was 32° F and the reactor cooling-jacket and chiller piping were frost covered. They were finally ready to proceed with the remaining steps in the procedure.

Figure 7. Isotainer (right) positioned adjacent to the process equipment.

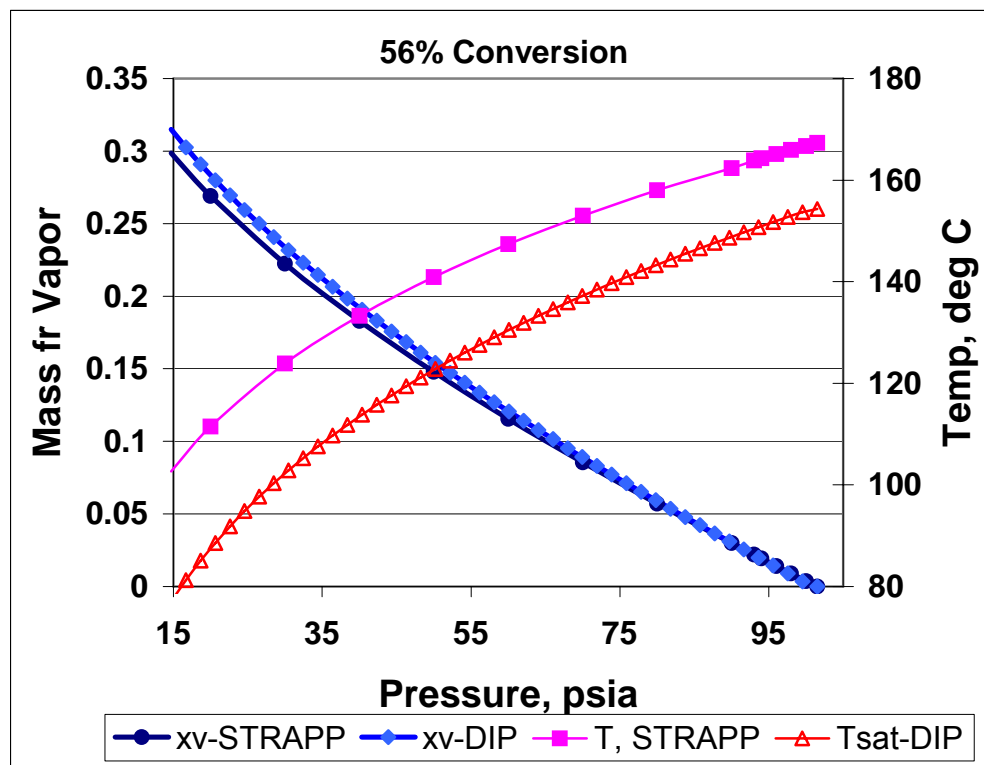
Next, the SafeSite3G™ and STRAPP models were used to develop a flash curve (Figure 1) for the initial conditions of the release. Two different models were required because the vapor liquid equilibrium properties of allyl alcohol and allyl chloride are distinctly non-ideal. The STRAPP model was used to determine the initial two-phase discharge rate using non-ideal vapor/liquid equilibrium correlations while the SafeSite3G™ model was used to predict the blowdown and dispersion.

Figure 1. Flash Curves by STRAPP and DIPPR Properties
