U.S. CHEMICAL SAFETY AND HAZARD INVESTIGATION BOARD

INVESTIGATION REPORT

LPG FIRE AT VALERO – MCKEE REFINERY

REPORT NO. 2007-05-I-TX

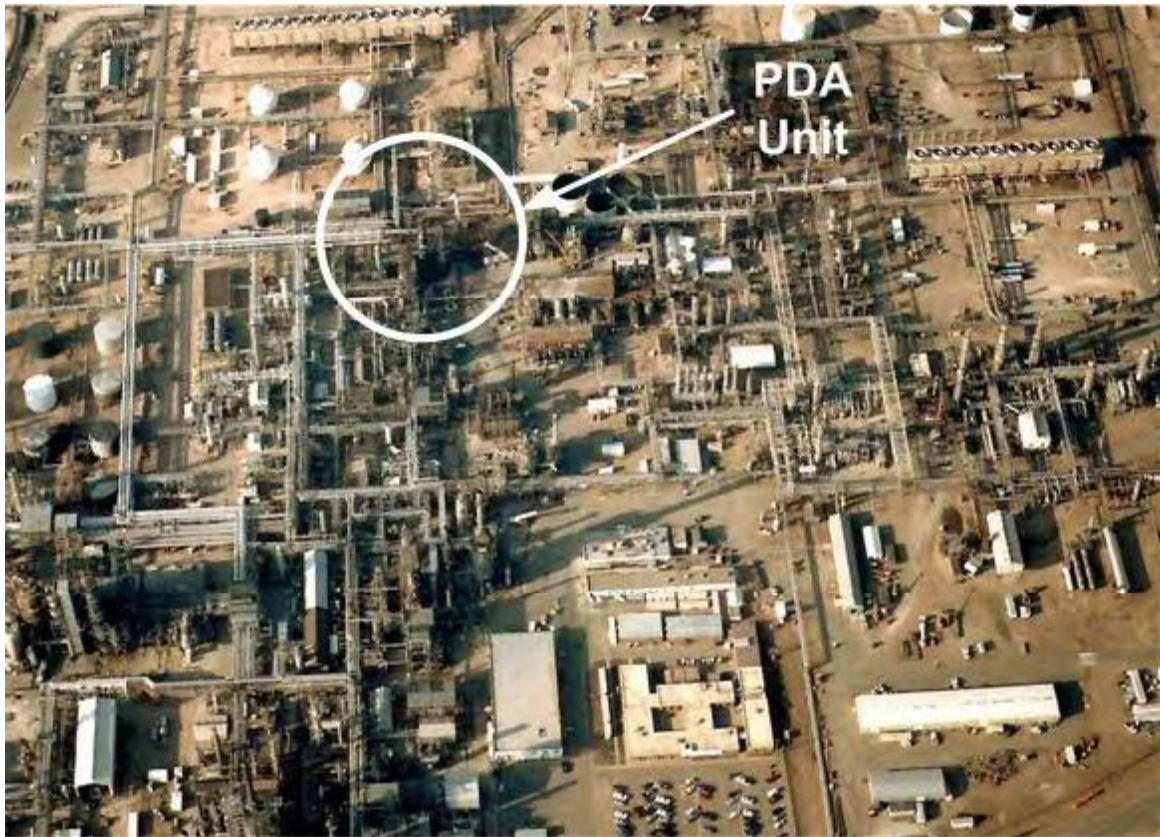
Figure 1. PDA unit location in the McKee Refinery

The PDA unit (Figure 1) recovered fuel feedstock and paving-grade asphalt from the heavy bottoms (pitch⁶) produced in the refinery's vacuum crude oil fractionator. In the McKee PDA process, two liquid/liquid extraction towers used liquid propane as a solvent to extract gas oil⁷ from the pitch under approximately 500 pounds per square inch (psi)(3,447 kPa) pressure. The recovered gas oil was processed into gasoline in another refinery unit. The asphalt produced was sold for use in paving materials. Figure 2 is a simplified process flow diagram for the No. 1 Extractor, including the location from which the propane was initially released.

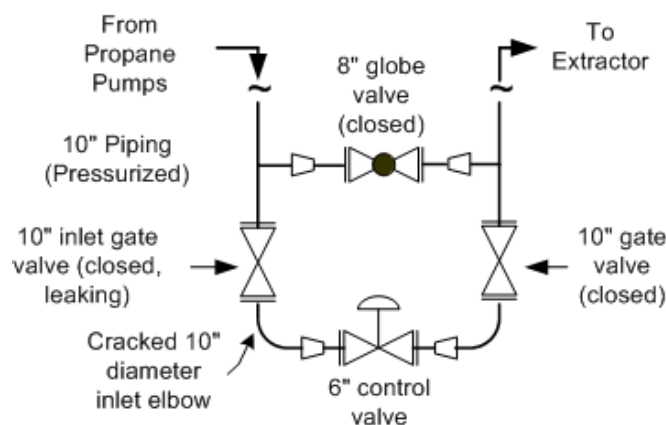
Figure 5. Propane mix control station schematic (not to scale)

In this incident, water settling out of a propane stream likely leaked through a 10" NPS²⁰ (250 DN) inlet block valve and accumulated in the low point formed by a control station (Figure 5). The control station was connected to the process, but had not been used for approximately 15 years. A period of cold weather likely froze the water, fracturing the pipe elbow upstream of the control valve. Warmer weather then melted the ice, resulting in a release of highly pressurized liquid propane through the fractured elbow. Appendix B contains a detailed time line of the incident.

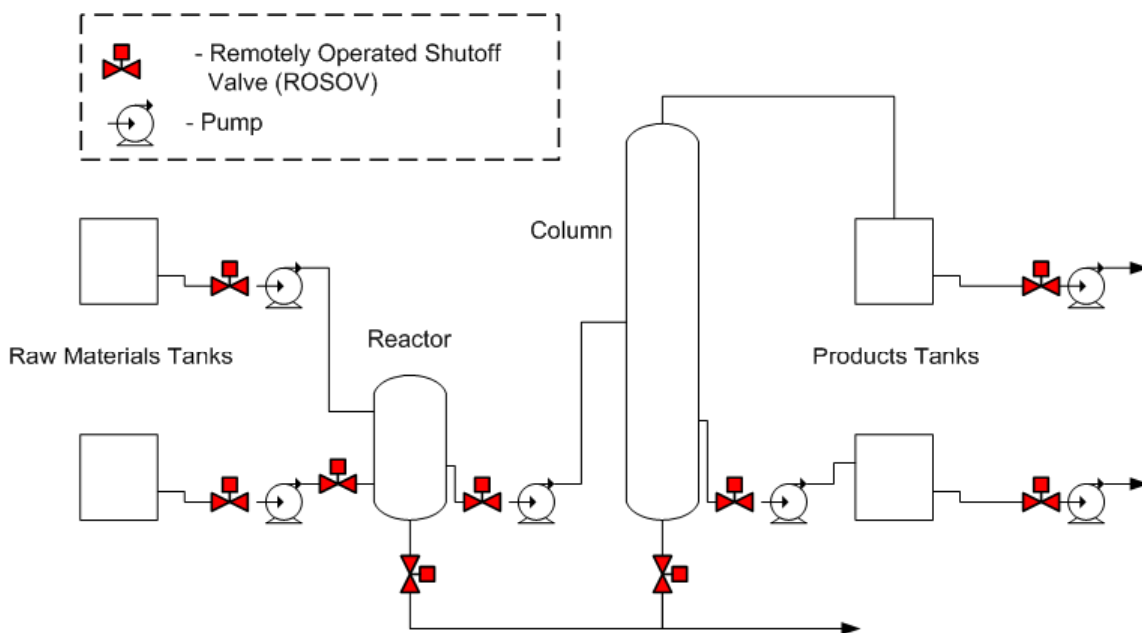
Figure 12. Insurer-recommended locations for ROSOVs

Although the PDA unit contained large inventories of high-pressure propane, it was not equipped with remotely operable shut-off valves (ROSOVs)³⁷ to rapidly stop propane releases. ROSOVs should be used in facilities, such as the PDA unit, where fast and effective isolation is needed to reduce the impact of major hazardous releases (HSE, 1999).

Figure 12 shows insurer-recommended ROSOV locations for a typical process unit. ROSOVs should be installed on large inventories of highly flammable materials,³⁸ especially when downstream pumps are present that could produce pressurized releases. Such pumps should be interlocked to shut down when ROSOVs are closed.

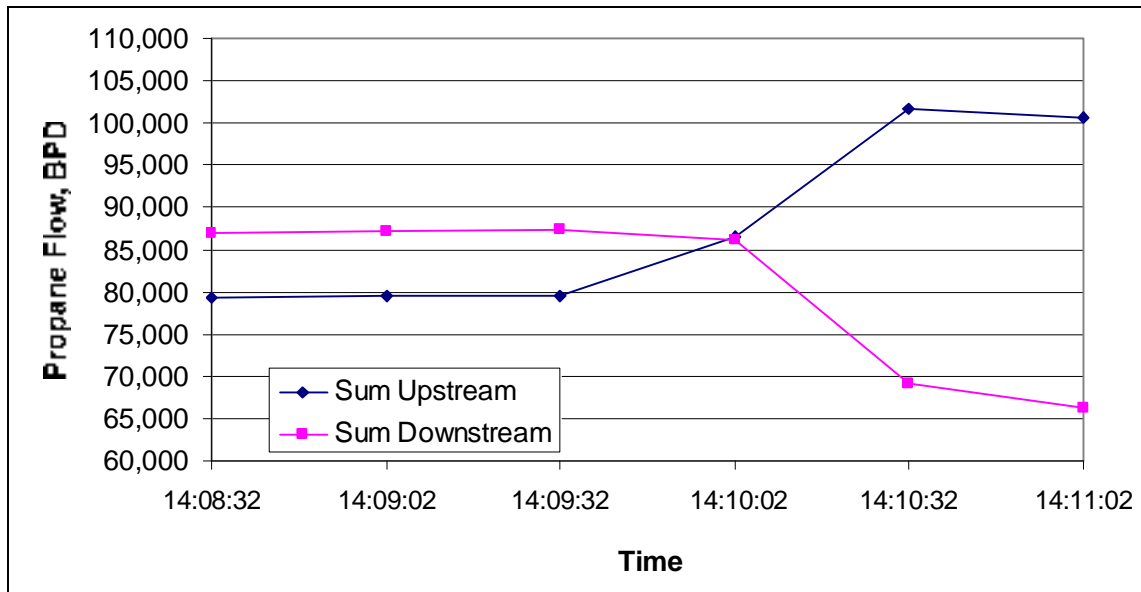
Figure D- 1. Changes in propane flows upstream and downstream of the cracked elbow

Figure 1 plots the sum of the upstream and downstream flow meter readings, in bpd.² The offset prior to the incident is due to an unmeasured process flow between the low- and high-pressure propane supplies upstream of the leak point. Assuming that this offset was fixed during the incident is conservative – the actual release rate was likely modestly higher than estimated here.

$$\begin{aligned} \text{Propane release rate} &= [\text{increase in upstream flow}] + [\text{decrease in downstream flow}] \\ &= [21,900] + [19,500] = 41,400 \text{ bpd.} \end{aligned}$$

Based on a liquid propane density of 27.7 lb per cubic foot at process conditions, the CSB estimated an initial release rate of 4,500 lb/min.
